State-Licensed Disposal Area at West Valley: 2023 Annual Report

Final Report | March 2024

State-Licensed Disposal Area at West Valley

2023 Final Report

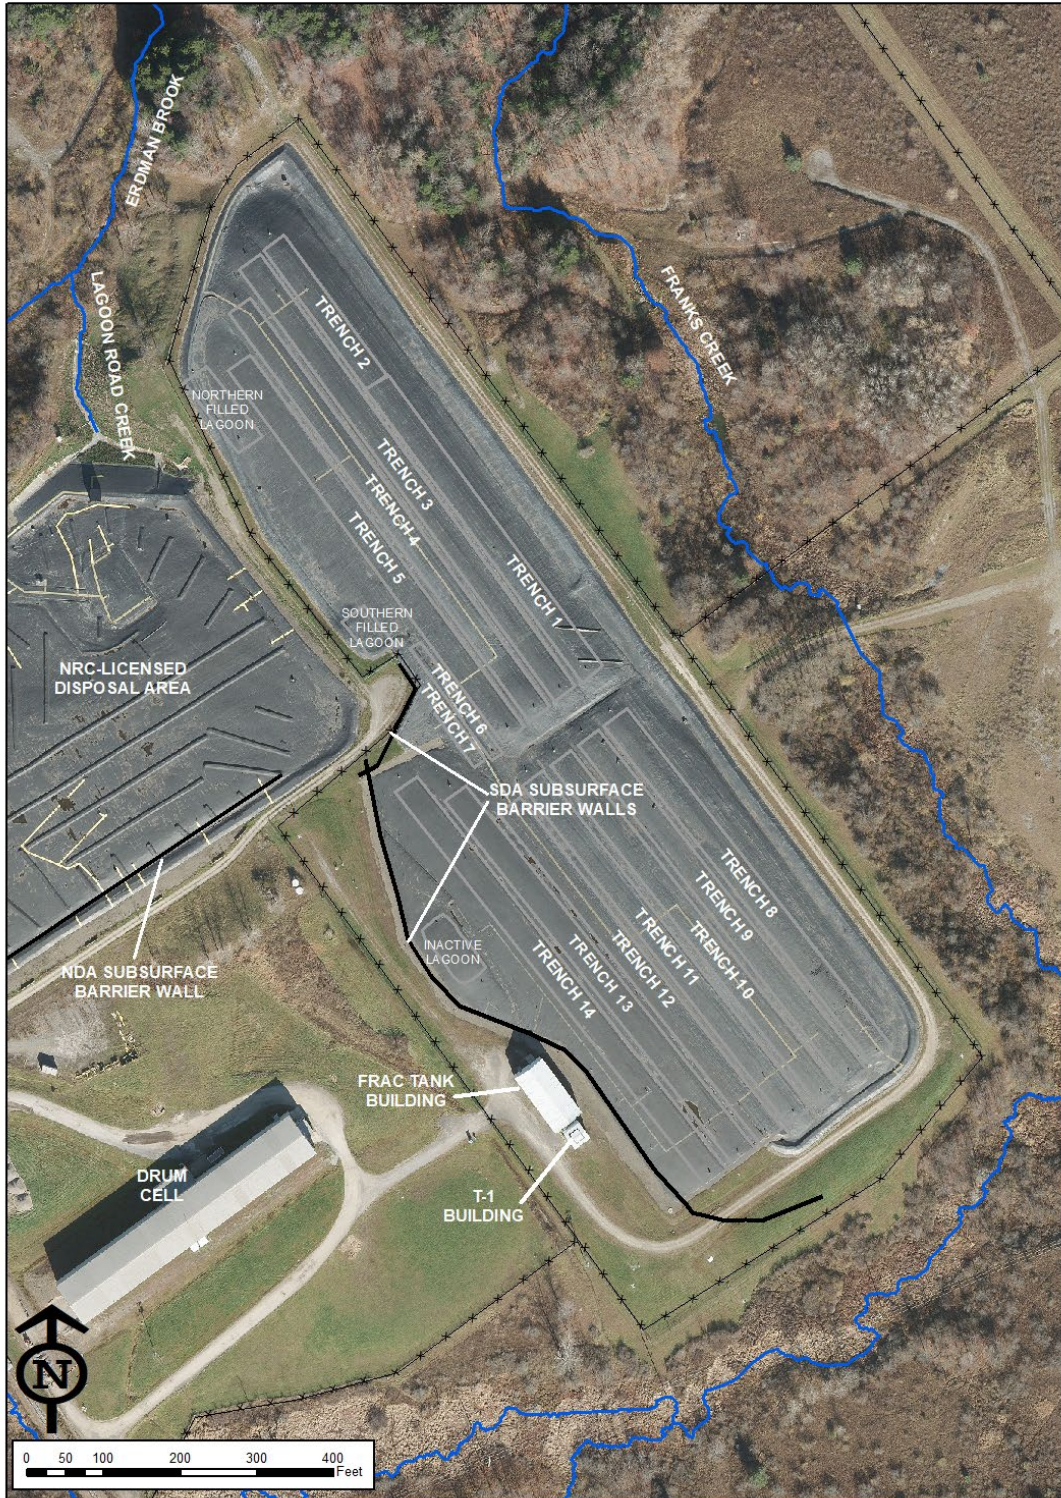
Figure 1-2. Aerial Photograph of the SDA

The SDA occupies approximately 15 acres of the WYNNSC (Figure 1-1) immediately adjacent to the West Valley Demonstration Project (WVDP). The SDA consists of three filled lagoons and two sets of parallel trenches that contain radioactive waste: 1 through 7 in the northern area and 8 through 14 in the southern area (see Figure 1-2). The SDA is surrounded by an eight-foot-high, chain-link fence, which includes a one-foot barbed-wire outrigger. NYSERDA controls access to the SDA by limiting the issuance of keys to the six, locked SDA gates. In addition, a contracted security service conducts routine patrols of the SDA's perimeter.

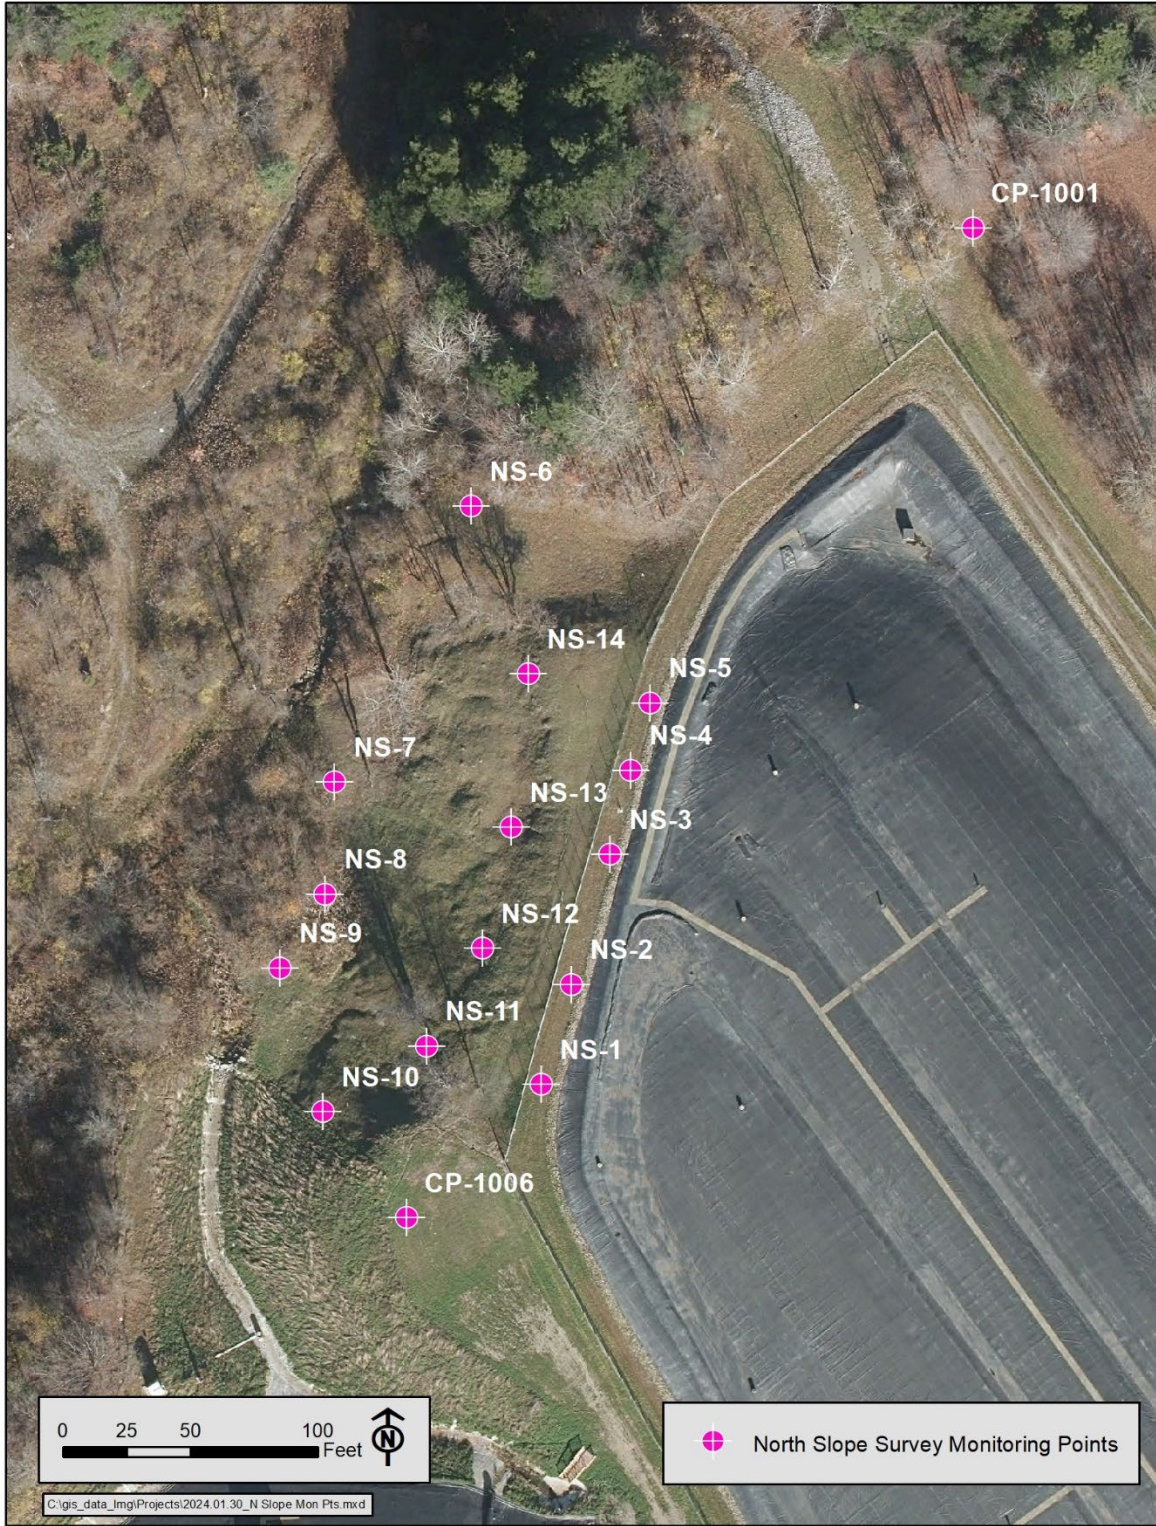
Figure 4-2. North Slope Survey Points

- Conducted focused topographic surveys of trench cap subsidence areas.
- Installed and surveyed in the new Control Point 1006 for the North Slope which replaces survey point CP-53, which was removed during the North Slope stabilization project.
- Completed installation of the fourteen new survey points on the North Slope to monitor for potential movement of the North Slope post construction.
