State-Licensed Disposal Area at West Valley: 2019 Annual Report

Final Report - March 2020

State-Licensed Disposal Area at West Valley:

2019 Final Report

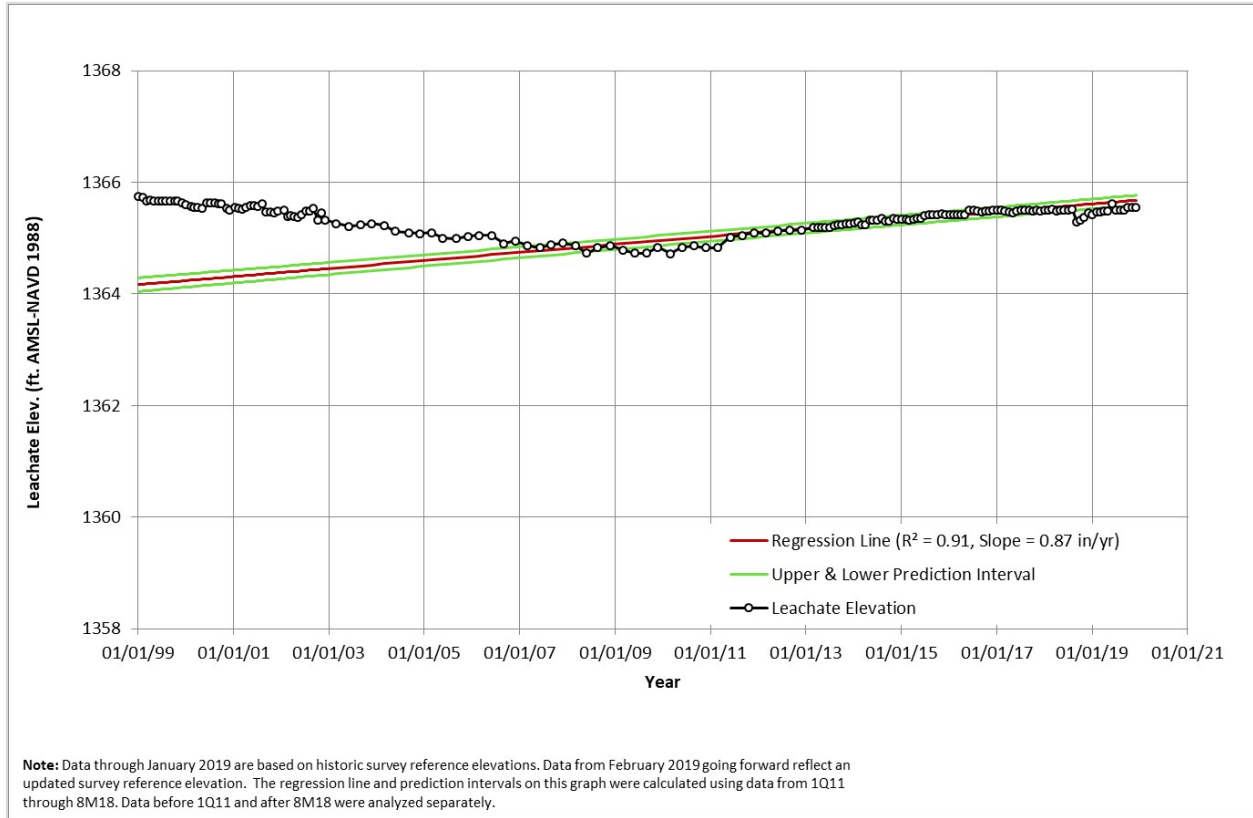
Figure 2-4. Trench 14 Leachate Elevations for the Period 2011 to 2018

Regression line is shown in red, with the 95 percent prediction interval shown in green.

Following the installation of infiltration controls in the mid-1990s, the Trench 14 leachate elevation followed a consistent and generally predictable decreasing trend (Figures 2-3 and A-14). A noteworthy change in behavior of this trend occurred in approximately 2008 through 2011 when the decreasing trend leveled off, as shown in Figure 2-4.
