State-Licensed Disposal Area at West Valley: 2018 Annual Report

Final Report - March 2019

New York State Energy Research and Development Authority

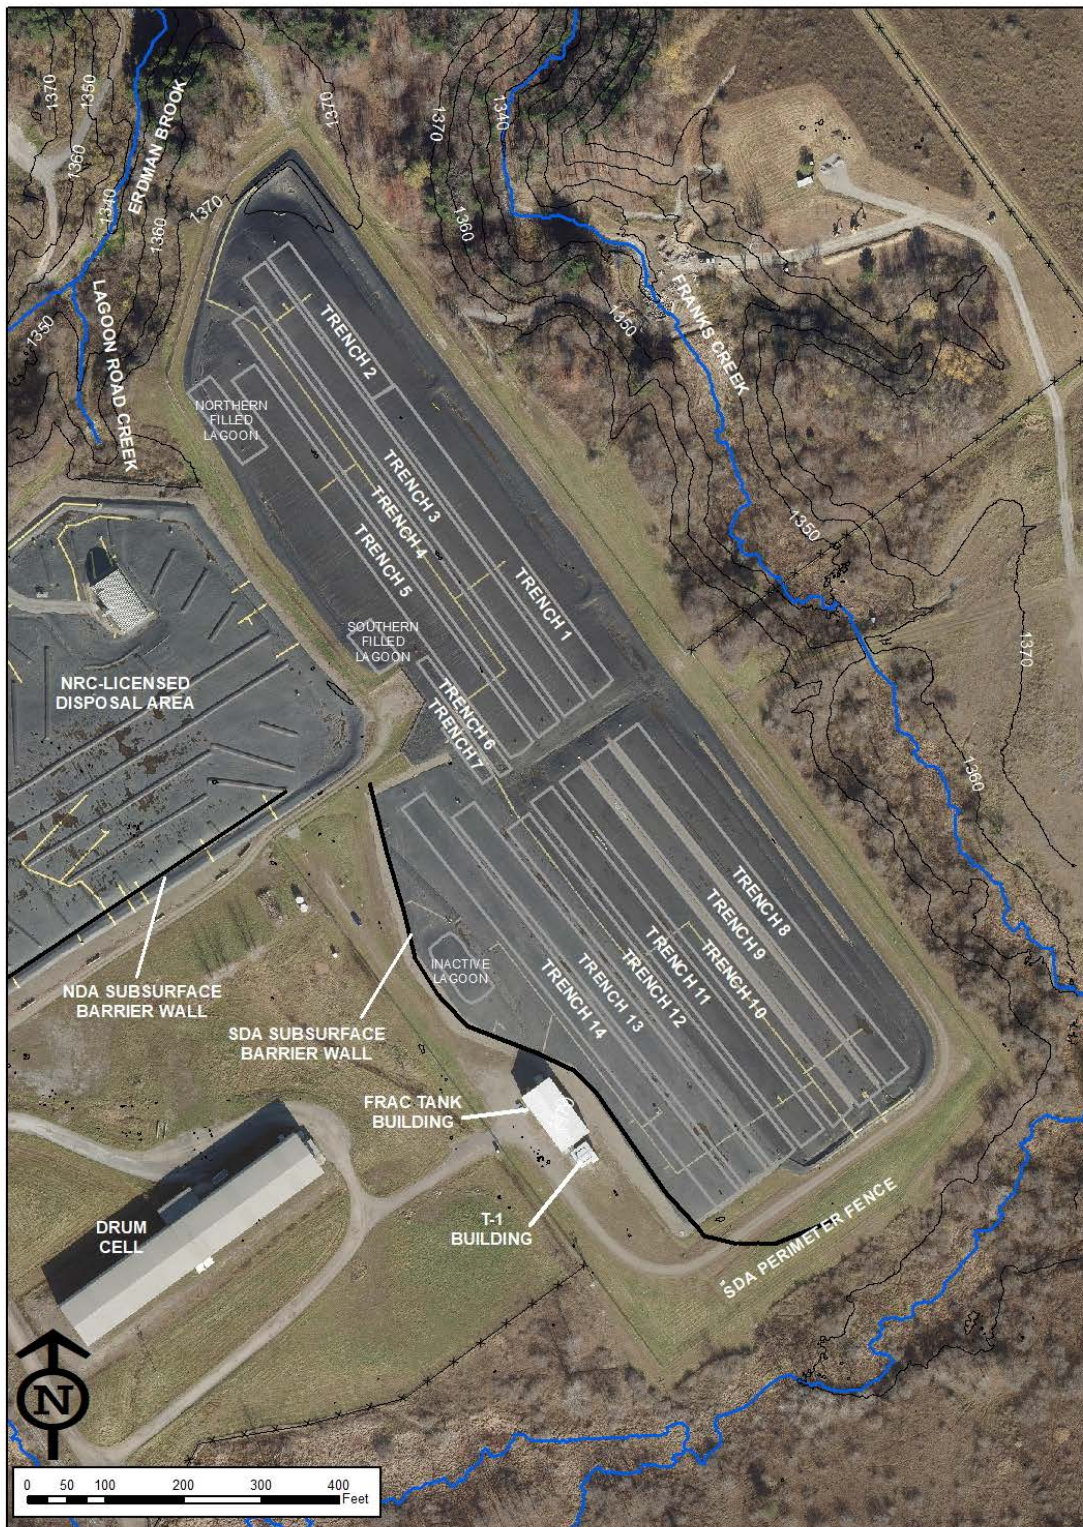
Figure 1-2. Aerial Photograph of the SDA

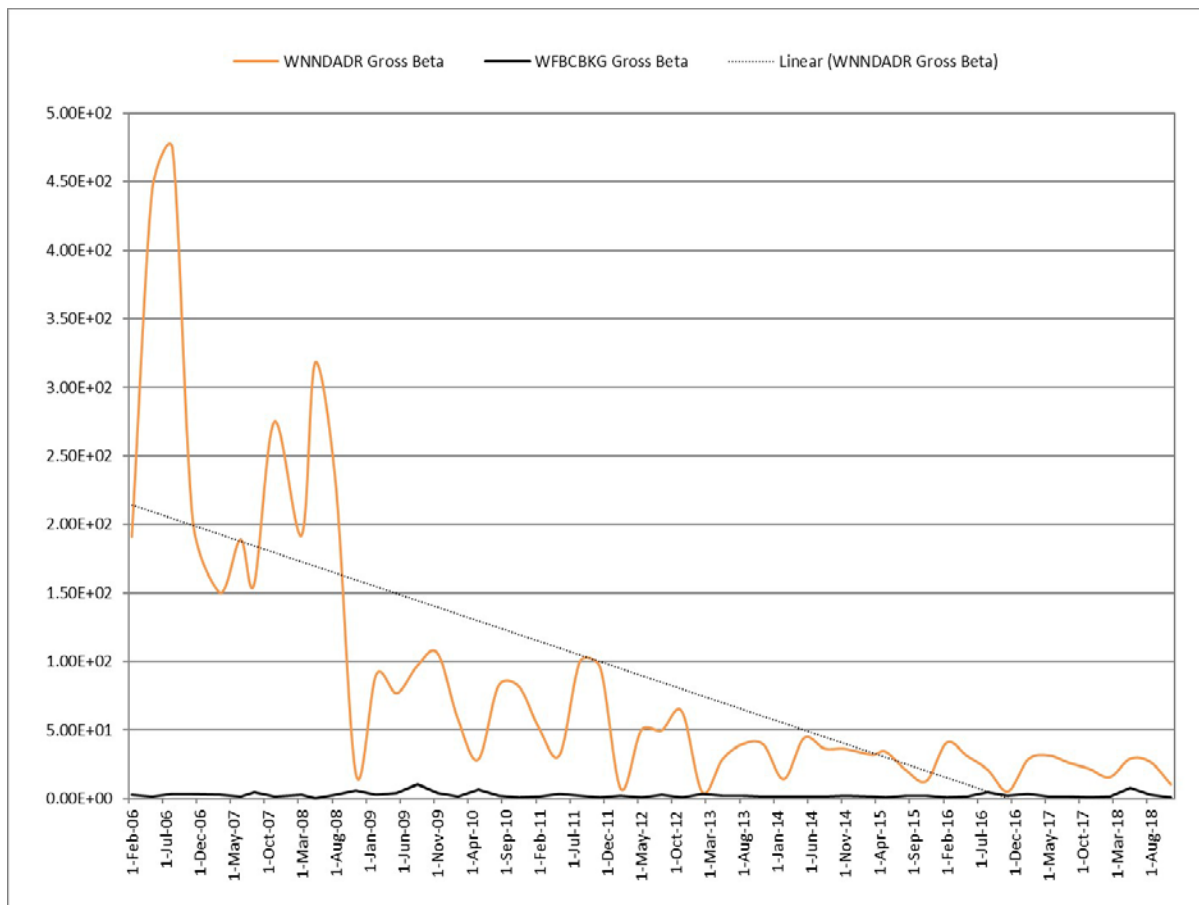
Figure 2-8. Gross Beta Results for Surface Water Monitoring Location WNDADR Compared to WFBCBKG

The 2018 gross beta results for WNNADR were statistically higher than the background locations, which is consistent with historical results, although levels at the WNNADR have fallen since the NDA geomembrane cover and subsurface barrier wall were installed in 2008. Figure 2-8 shows the gross beta results for the WNNADR location and the background location (WFBCBKG). Gross beta results for WNERB53 were statistically higher than background from 2012 through 2016, but in 2017 and 2018 were found to be statistically indistinguishable from background. The 2018 results for WNFRC67 and

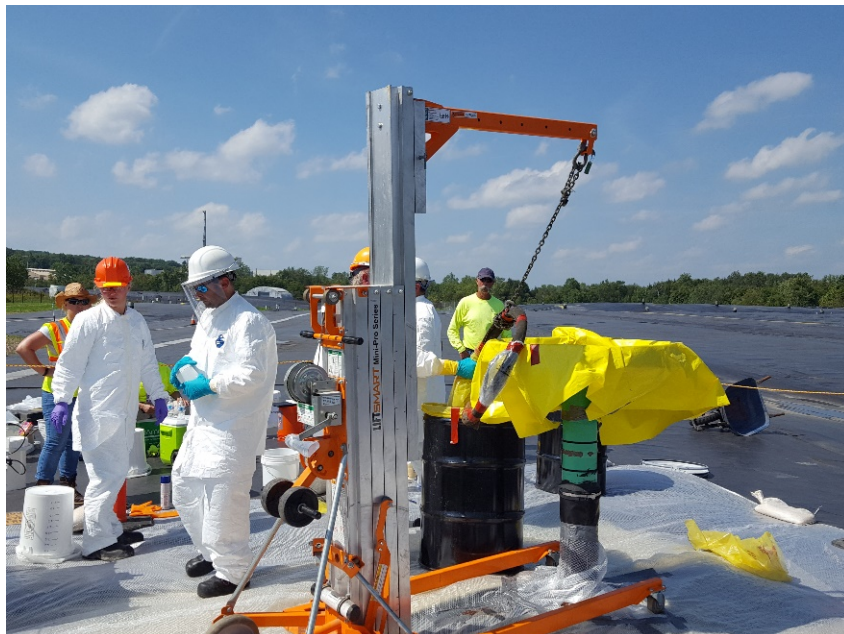
Figure 4-1. Trench 14 ancillary equipment removal

- repair of the SDA security light and vestibule space heater
- investigation of Trench 13 subsidence
- removal of the Trench 14 sump pump cover and ancillary equipment (e.g., electrical wiring, tubing, and pump), and installation of a new locking cap on the sump stand pipe (see Figure 4-1)
- installation of two new above-grade wind anchors along the south end of Trench 1 (see Figure 4-2) to add weight to the cover to prevent movement
- installation of a temporary stormwater flow meter in the W-05 stormwater chamber (see Figure 4-3)
- reconfiguration of the south detention basin (see Figures 4-4 and 4-5) to promote proper drainage

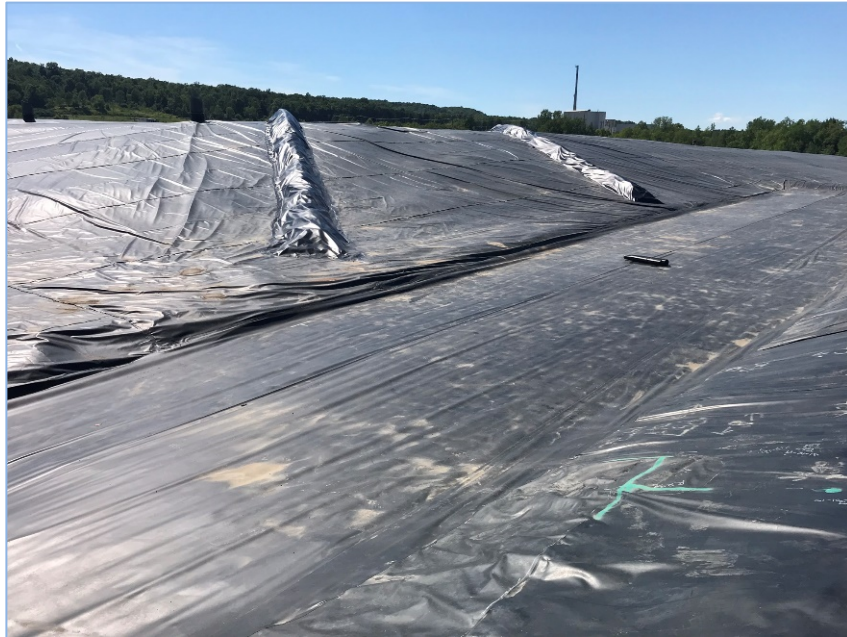
Figure 4-2. Trench 1 above-grade wind anchors

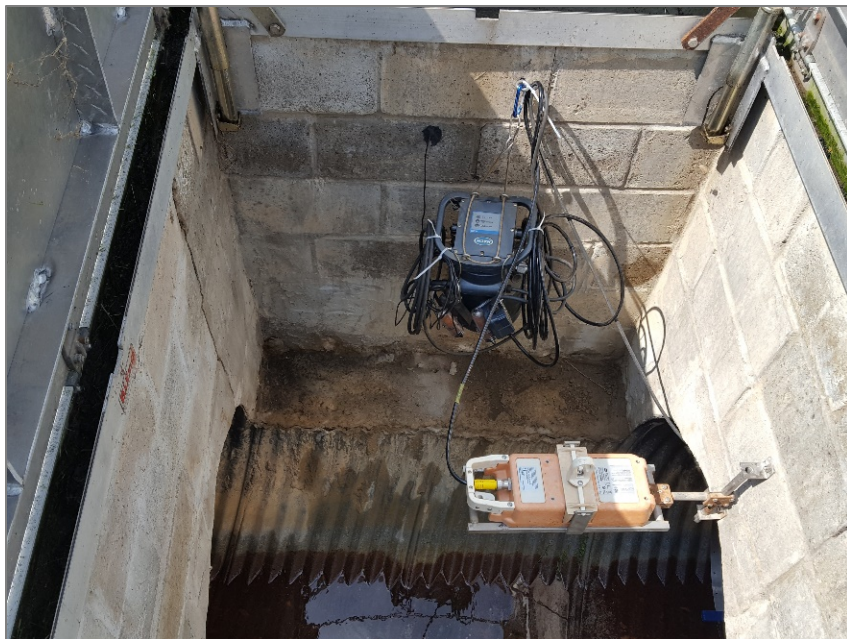
Figure 4-3. W-05 Stormwater Flowmeter

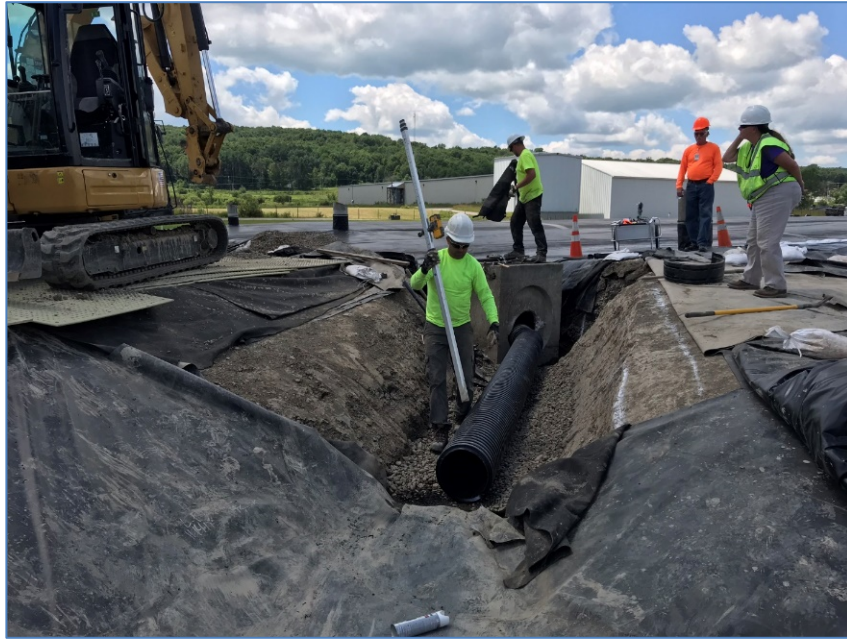
Figure 4-4. South detention basin reconfiguration

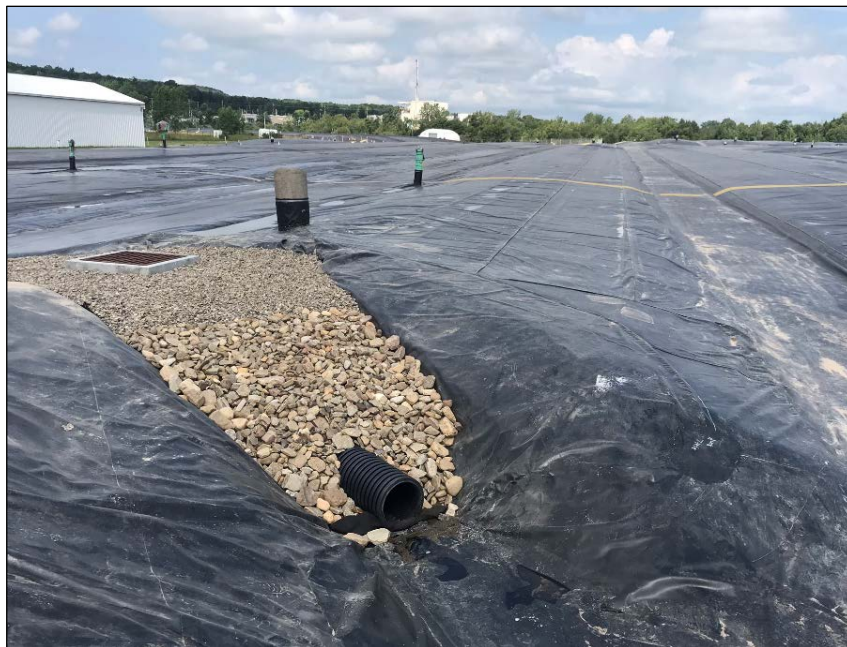
Figure 4-5. South detention basin completed work

In 2017, NYSERDA completed installation of a new geomembrane cover over Trenches 1-12 and improved the stormwater collection system (including the removal of stormwater outfall location No. 3). All field work was completed, with the exception of reshaping and replacing the existing outlet pipe for the south detention basin (see Figure 4-4), which was completed during 2018. The 2018 field work provided additional stormwater capacity and replaced an uneven pipe that retained water. Upon completion of this work, the contractor welded a new piece of geomembrane cover over the existing cover and realigned the slope of the piping to eliminate ponding (see Figure 4-5).

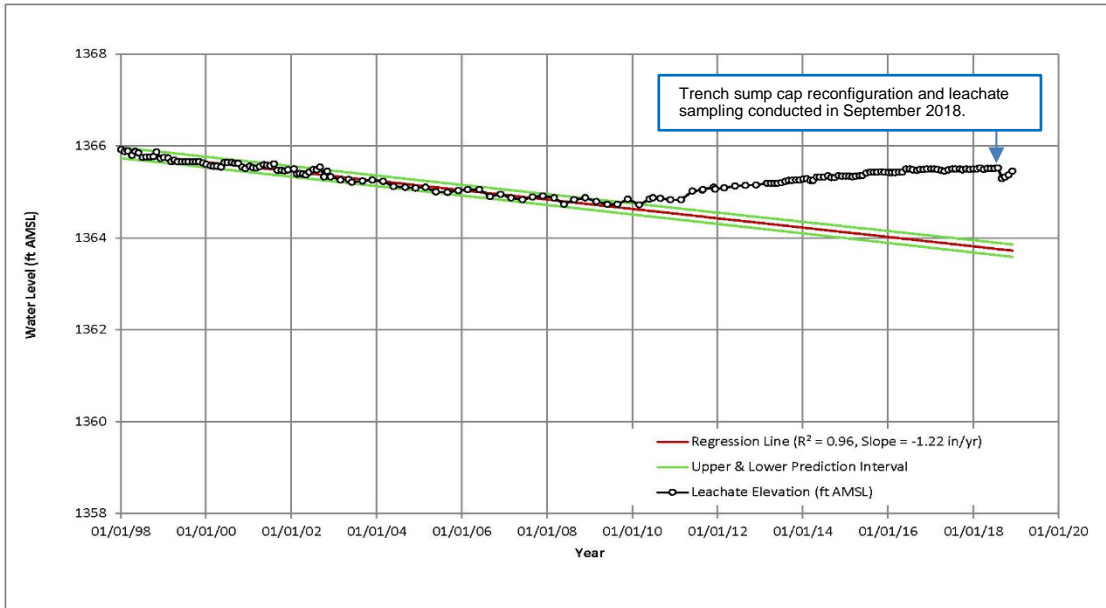
Figure A-13. Trench 14 Leachate Elevations for the Period 1998 to 2008

As described below, an increase in the Trench 14 leachate elevation has been observed since 2011 following a period of consistent decrease (Figures 2-3 and A-13); but due to the long-term decreasing trend for Trench 14, this increase is not identified using the Mann-Kendall with Sen's method test. As such, NYSERDA instituted the regression analysis as another tool to evaluate leachate elevation changes. Based on the regression analysis plotted in Figures 2-4 and A-14, Trench 14 has been increasing at approximately 0.77 inches per year (since 2011). Monitoring of Location WP-91 began in 2013 to supplement data from Trench 14. Based on the regression analysis plotted in Figure A-15, Trench 14 at WP-91 has been increasing at approximately 0.25 inches per year.

Following the installation of infiltration controls in the mid-1990s, the Trench 14 leachate elevation followed a consistent and generally predictable decreasing trend (Figures 2-3 and A-13). A noteworthy change in behavior of this trend occurred in approximately 2008 through 2011 when the decreasing trench leveled off, as shown in Figure 2-3.
