State-Licensed Disposal Area at West Valley: 2017 Annual Report

Final Report - March 2018

New York State Energy Research and Development Authority

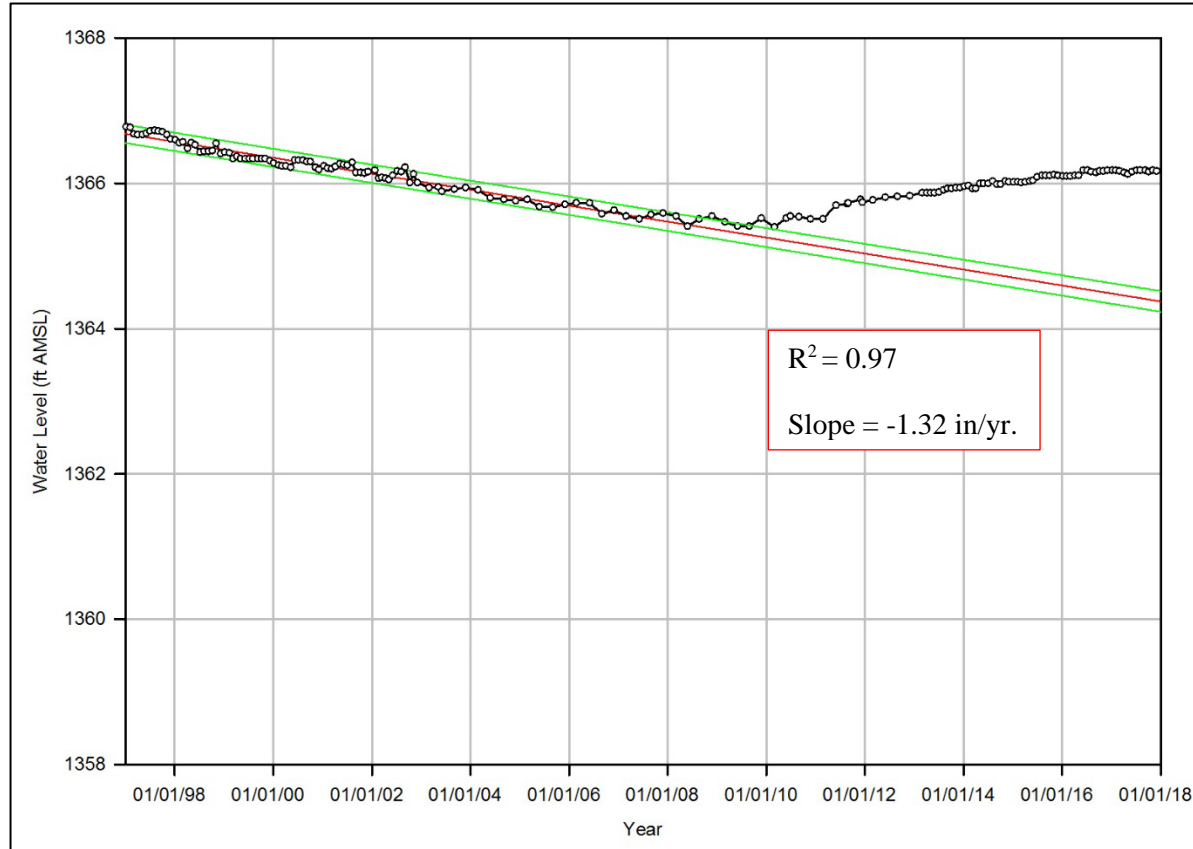
Figure 2-3. Trench 14 Leachate Elevation for the Period 1997 to 2017, Regression Analysis Shown for 1997 to 2008

Regression line shown in red. 95% Prediction intervals shown in green.

Following the installation of infiltration controls in the mid-1990s, the Trench 14 leachate elevation followed a consistent and generally predictable decreasing trend (Figures 2-3 and A-13). A noteworthy change in behavior of this trend occurred in approximately 2008 through 2011 when the decreasing trend leveled off, as shown in Figure 2-3.

As described below, an increase in the Trench 14 leachate elevation has been observed since 2011 following a period of consistent decrease (Figures 2-3 and A-13); but due to the long-term decreasing trend for Trench 14, this increase is not identified using the Mann-Kendall with Sen's method test. As such, NYSERDA instituted the regression analysis as another tool to evaluate leachate elevation changes. Based on the regression analysis plotted in Figures 2-4 and A-14, Trench 14 has been increasing at approximately 0.87 inches per year (since 2011). Monitoring of Location WP-91 began in 2013 to supplement data from Trench 14. Based on the regression analysis plotted in Figure A-15, Trench 14 at WP-91 has been increasing at approximately 0.67 inches per year.

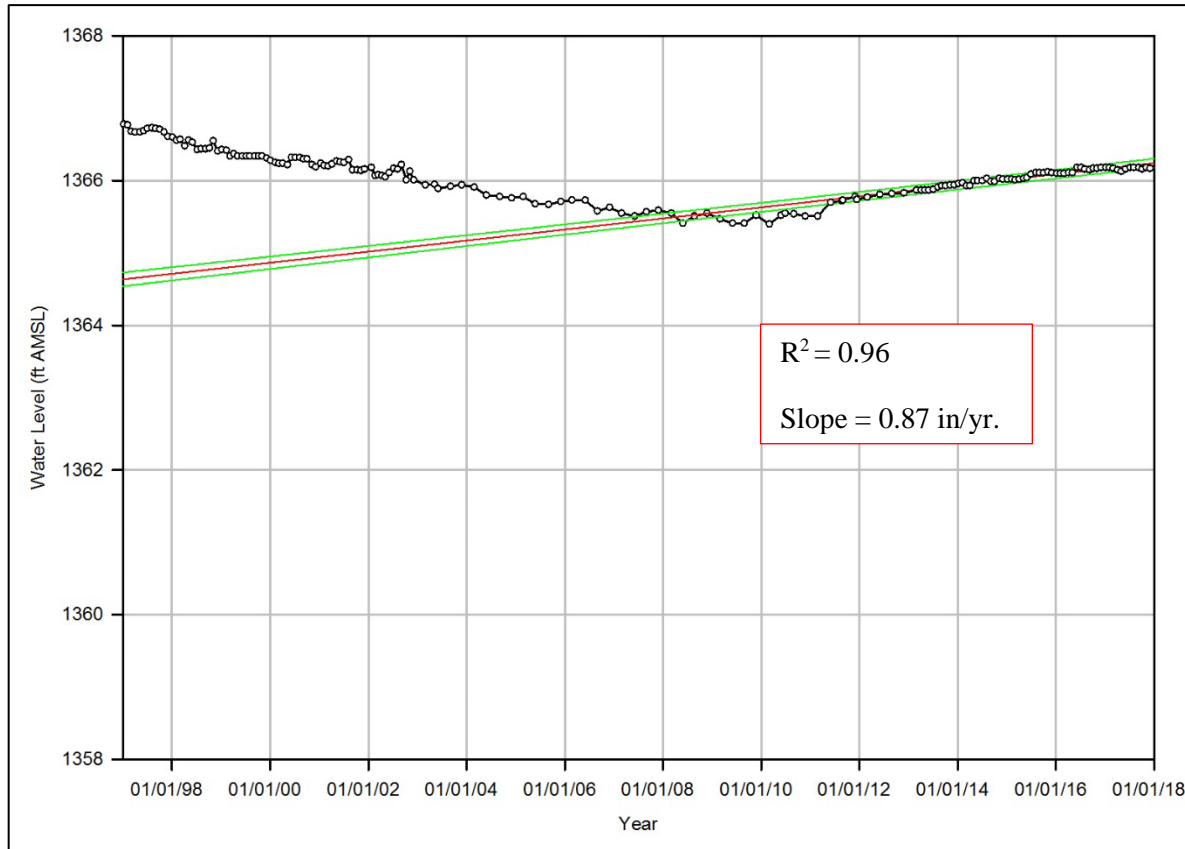
Figure 2-4. Trench 14 Leachate Elevations for the Period 1997 to 2017, Regression Analysis Shown for 2011 to 2017

Regression line shown in red. 95% Prediction intervals shown in green.

The current leachate levels do not represent a threat of release, or concern to health and safety to the public or the environment. NYSERDA will continue to review and evaluate leachate trends in the trenches using the regression analyses to identify changes in trends that may not be identified using the historical long-term statistical analysis.

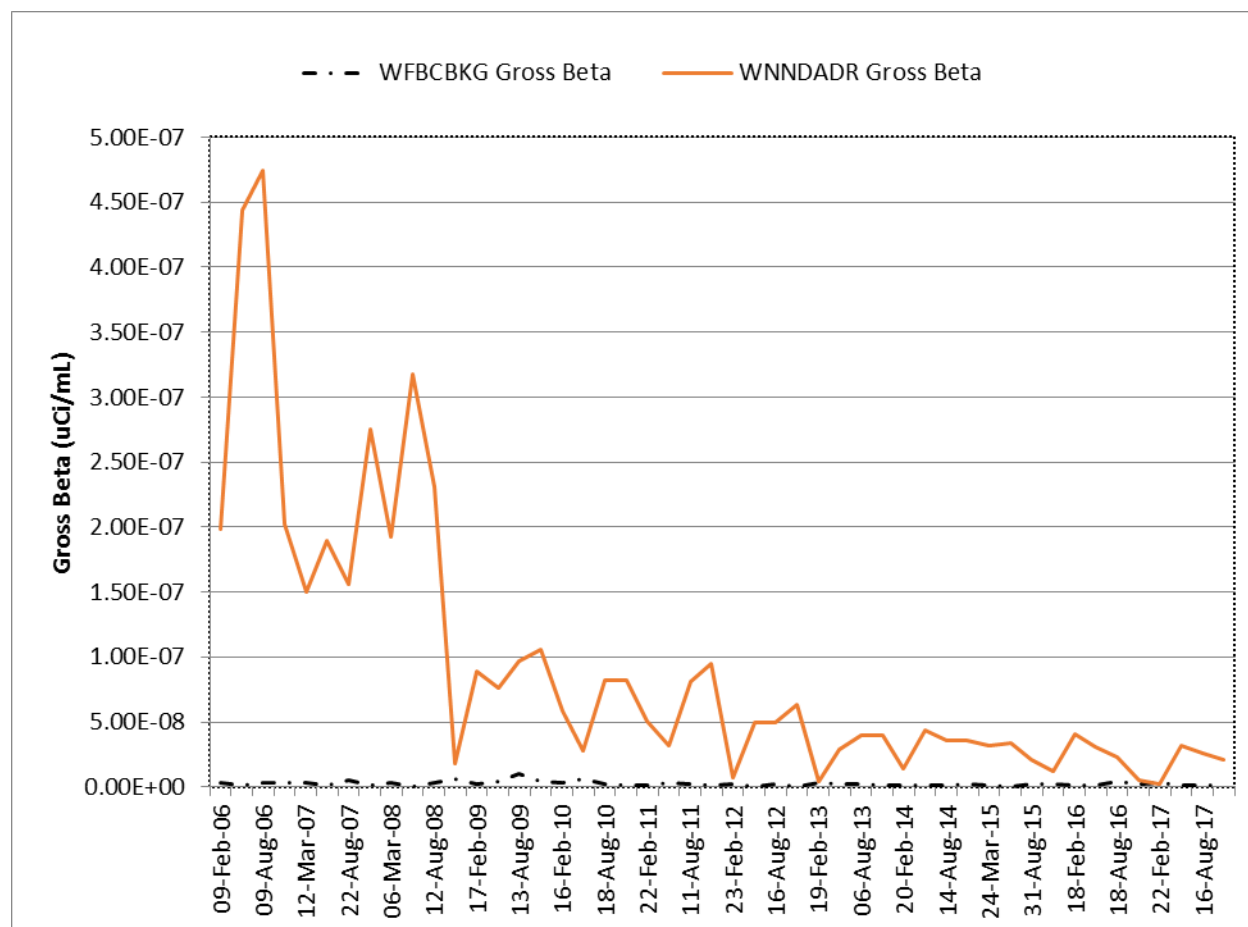
Figure 2-8. Gross Beta Results for Surface Water Monitoring Location WNNADR Compared to WFBCBK

The 2017 gross beta results for WNNADR were statistically higher than the background locations, which is consistent with historical results, although levels at the WNNADR have fallen since the NDA geomembrane cover and subsurface barrier wall were installed in 2008. Figure 2-8 shows the gross beta results for the WNNADR location and the background location (WFBCBK). Gross beta results for WNERB53 and WNDCEL were statistically higher than background in 2016, but in 2017 were found to be statistically indistinguishable from background. The 2017 results for WNFRC67 were statistically indistinguishable from background, which is consistent with previous annual assessments. All gross beta results were below 6 NYCRR 703.5 (1.0E-6 $\mu\text{Ci}/\text{mL}$), which is used as a comparative value for gross beta.

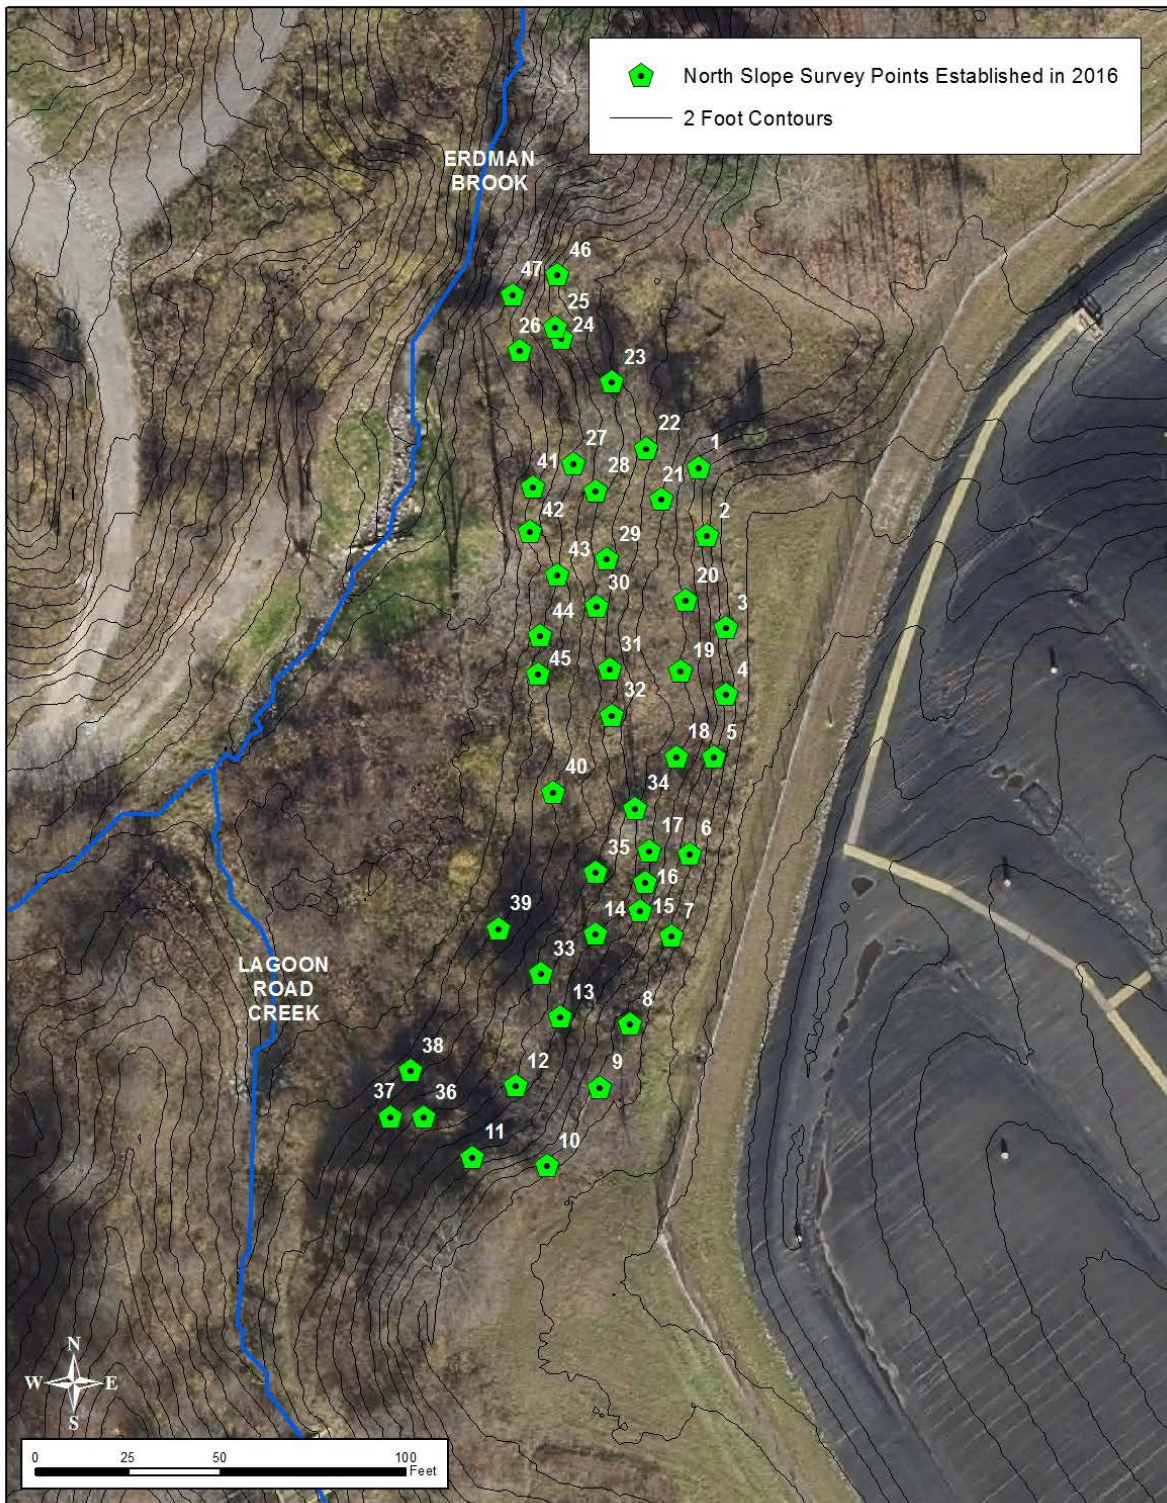
Figure 3-1. North Slope Ground Surface Elevation Survey Points

In 2016, NYSERDA installed 47 new monitoring points on the north slope of the SDA to replace absent or damaged points, and had them surveyed on October 26, 2016. The new monitoring points were surveyed in the NAD 83 and NAVD 88 coordinate system, and will be used as comparative monitoring points from year to year.

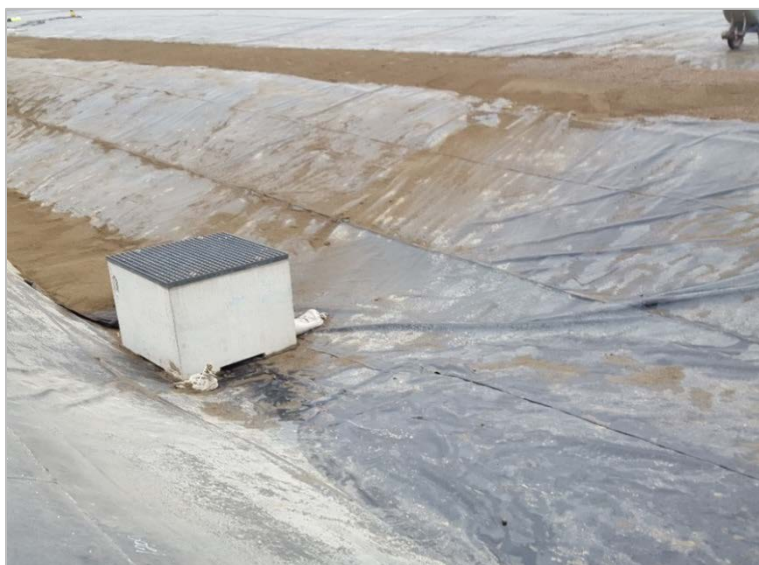
Figure 4-1. New Stormwater Structure Base Section

and combining stormwater catchments No. 2 and 3, thereby reducing the erosion potential to the east slope of the SDA (see Figure 4-1 for a typical base section of the new stormwater structures). Additional preparatory work included removal of wind anchor ballast material from in between the trench caps and along the perimeter. Figure 4-2 shows the vacuum truck operations removing stone ballast from an anchor trench. Some areas of observed subsidence were filled with sand and engineered fabric, while other areas with more subsidence (i.e., south end of Trench 8) had to be built up with geo-foam blocks, and then covered with geomembrane (see Figure 4-3).

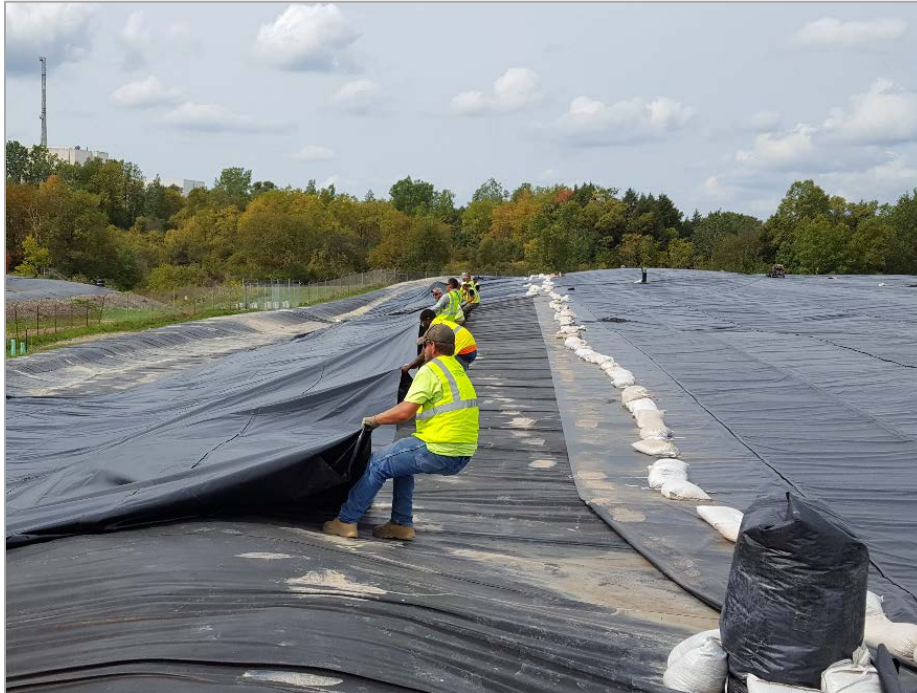
Figure 4-4. Placement of XR-5 panel

The new geomembrane cover installation project was fabricated offsite. The 28 fabricated panels were shipped to the SDA, placed in order of installation, and welded together. (Figure 4-4 shows a panel being pulled and aligned with an adjacent panel for welding.) After the panels were installed, the sand ballast previously removed from the anchor trenches (using a sand throwing machine capable of casting the sand over 100 ft) was replaced. The sand was then graded out at a one percent slope to promote positive drainage and covered with an XR-5 cap. Figure 4-5 demonstrates the sand placement and XR-5 cap installation.

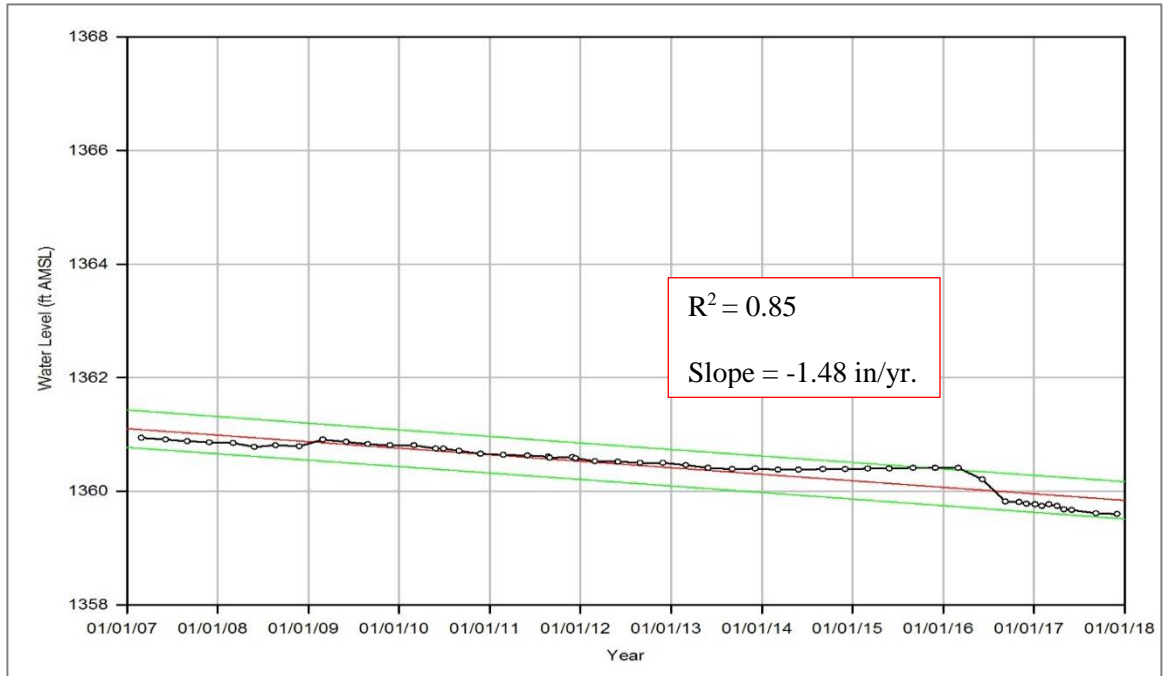
Figure A-3. 2007-2017 Leachate Elevations, Trench 3

In addition to the increasing trends identified in Trenches 1 and 14, a potential trend change had been noted for Trench 3 between 2014 and 2016 (see Figure A-3). A new measurement probe was installed in the third quarter of 2016, and measurements with the new indicator show that the leachate level is consistent with the long-term historical decreasing trend; thereby suggesting that the deviation from the historical trend was due to a malfunctioning measurement probe.

Trench 3 measurement probe was replaced in July 2016.

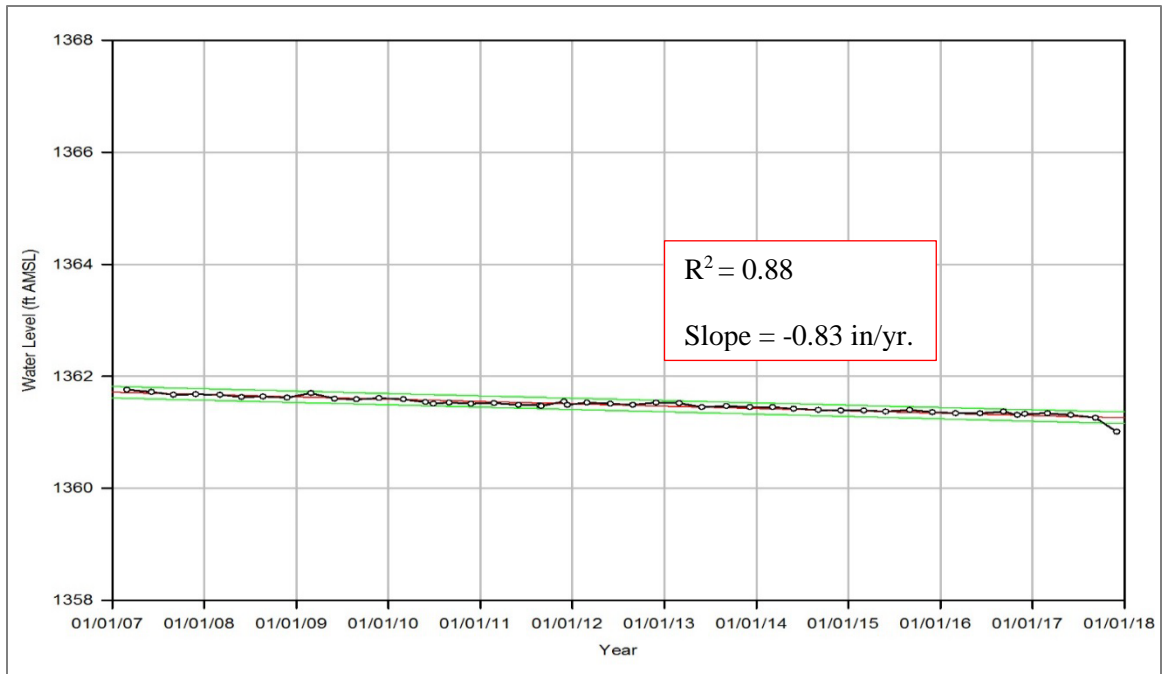
Figure A-6. 2007-2017 Leachate Elevations, Trench 8

In September 2017, as part of the geomembrane cover installation, the ground surface around the Trench 8 sump was raised and a 24-inch-long extension was added to the trench sump riser. The new Trench 8 sump riser pipe was surveyed to determine the new reference elevation for leachate level measurements, and the new reference elevation was surveyed at 1391.60 ft above mean sea level (AMSL) (National Geodetic Vertical Datum [NGVD] 1929). When the leachate level taken in September 2017 (prior to the riser extension) was compared to the new reference elevation, a difference of 0.25 ft was noted (Figure A-6). This difference is attributed to changes in survey locations and processes, and not representative of a change in leachate level at Trench 8.

Trench 8 sump riser extension was placed in September 2017.
