State-Licensed Disposal Area at West Valley: 2021 Annual Report

Final Report | March 2022

State-Licensed Disposal Area at West Valley

New York State Energy Research and Development Authority

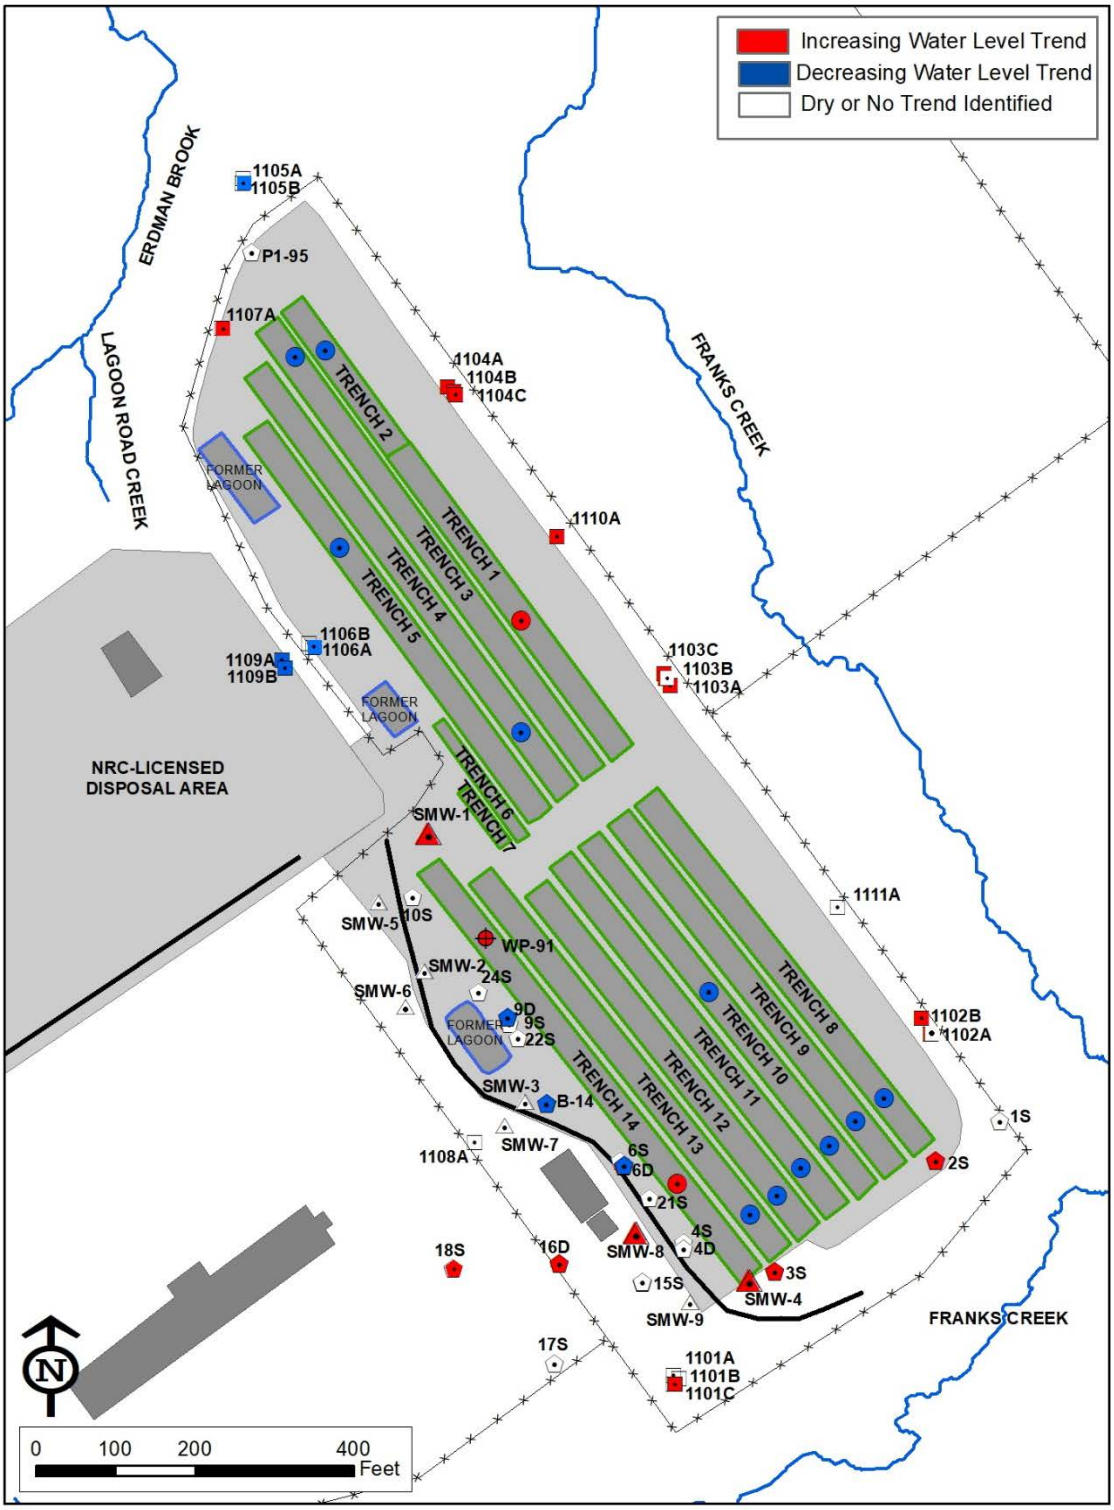
Figure 2-2. SDA Water Elevation Trends

The LMP requires an annual assessment of long-term leachate elevation trends. The long-term statistical data assessment for 2021 (*Annual Statistical Assessment of State-Licensed Disposal Area Water Elevations - Data Through 2021*[4]) indicates that from 2000 through 2021, most trenches show a decreasing long-term leachate elevation trend (see Figure 2-2).

As Figure 2-2 shows, the majority of the wells located within the area covered by the geomembrane and immediately downgradient of the slurry wall and subsurface sheet pile wall are dry or exhibit no trend. Four locations upgradient of the slurry wall show an increasing trend. The distribution of groundwater elevations near the west side of Trench 14, and the decreasing long-term leachate elevation trends in all but two of the SDA trenches, reflect the continued effectiveness of the water infiltration controls system (i.e., subsurface barrier walls and geomembrane cover).

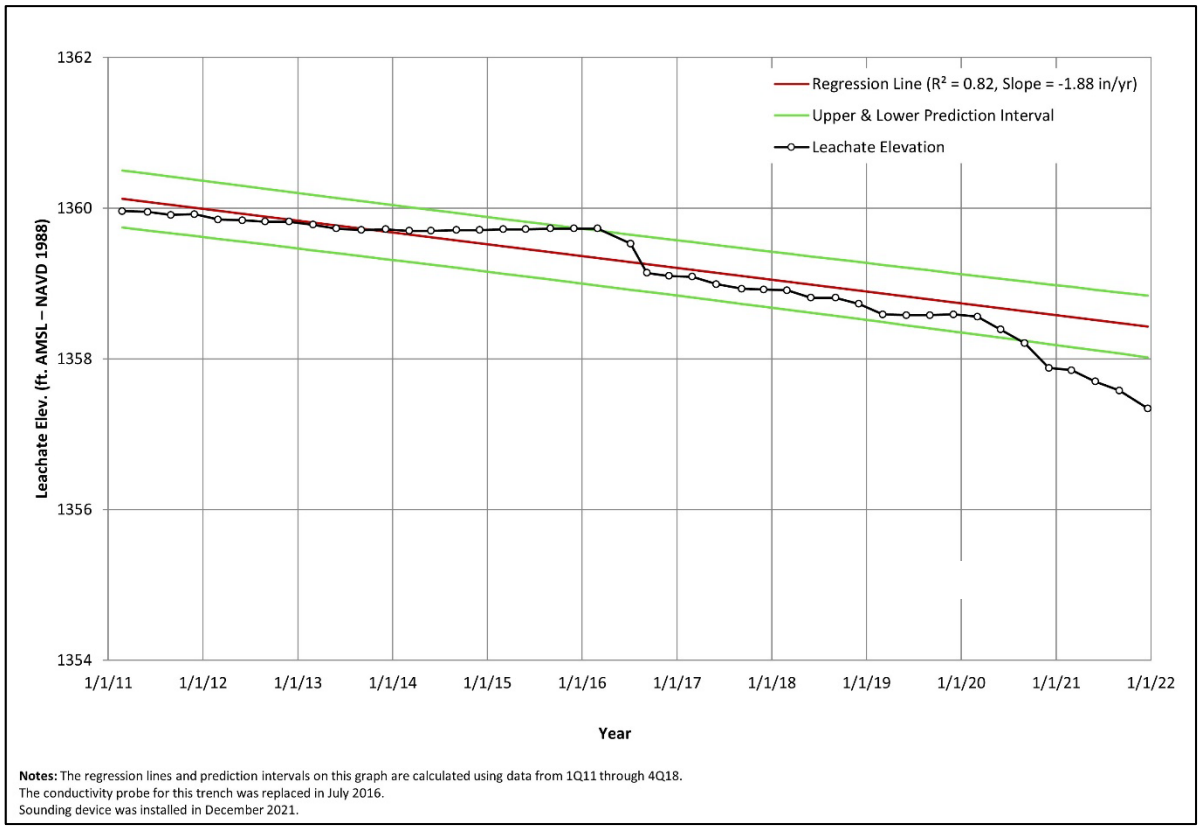
An evaluation of the surrounding trenches and monitoring locations did not indicate any similar changes or potential indicators of this change. The change necessitates a separate regression line for the Trench 3 graph to accurately demonstrate current leachate trending conditions at this location (Figures 2-3 and A-4, and Figures 2-4 and A-5).

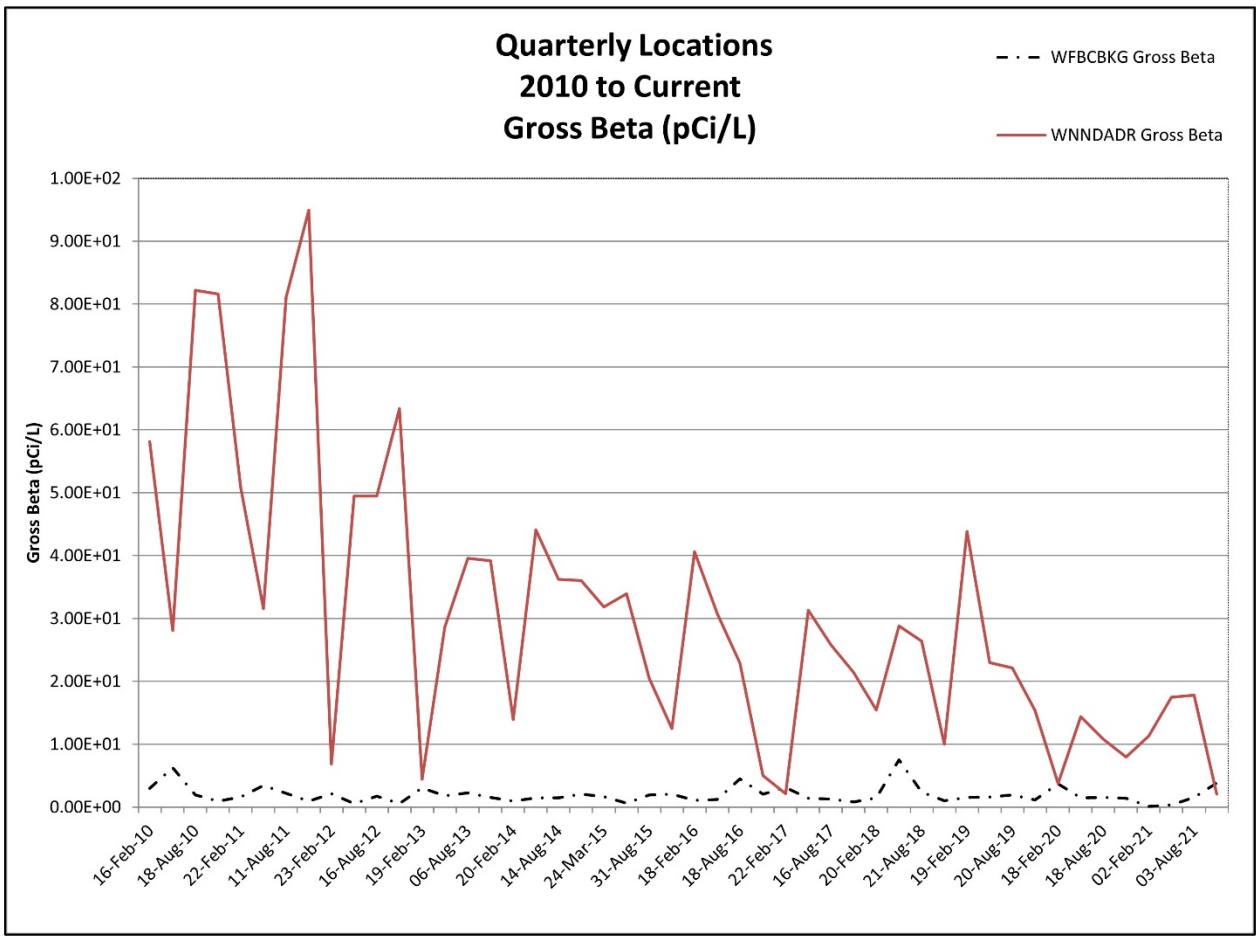
Figure 2-8. Gross Beta Results for Surface Water Monitoring Locations WNNDADR Compared to WFBCBKG

The 2021 gross beta results for WNDCELD, WNFRC67, and WNERB53 were statistically indistinguishable from background. Gross beta results for WNNDADR were statistically higher than background; however, the results continue to decrease since the NDA geomembrane cover and subsurface barrier wall were installed in 2008.

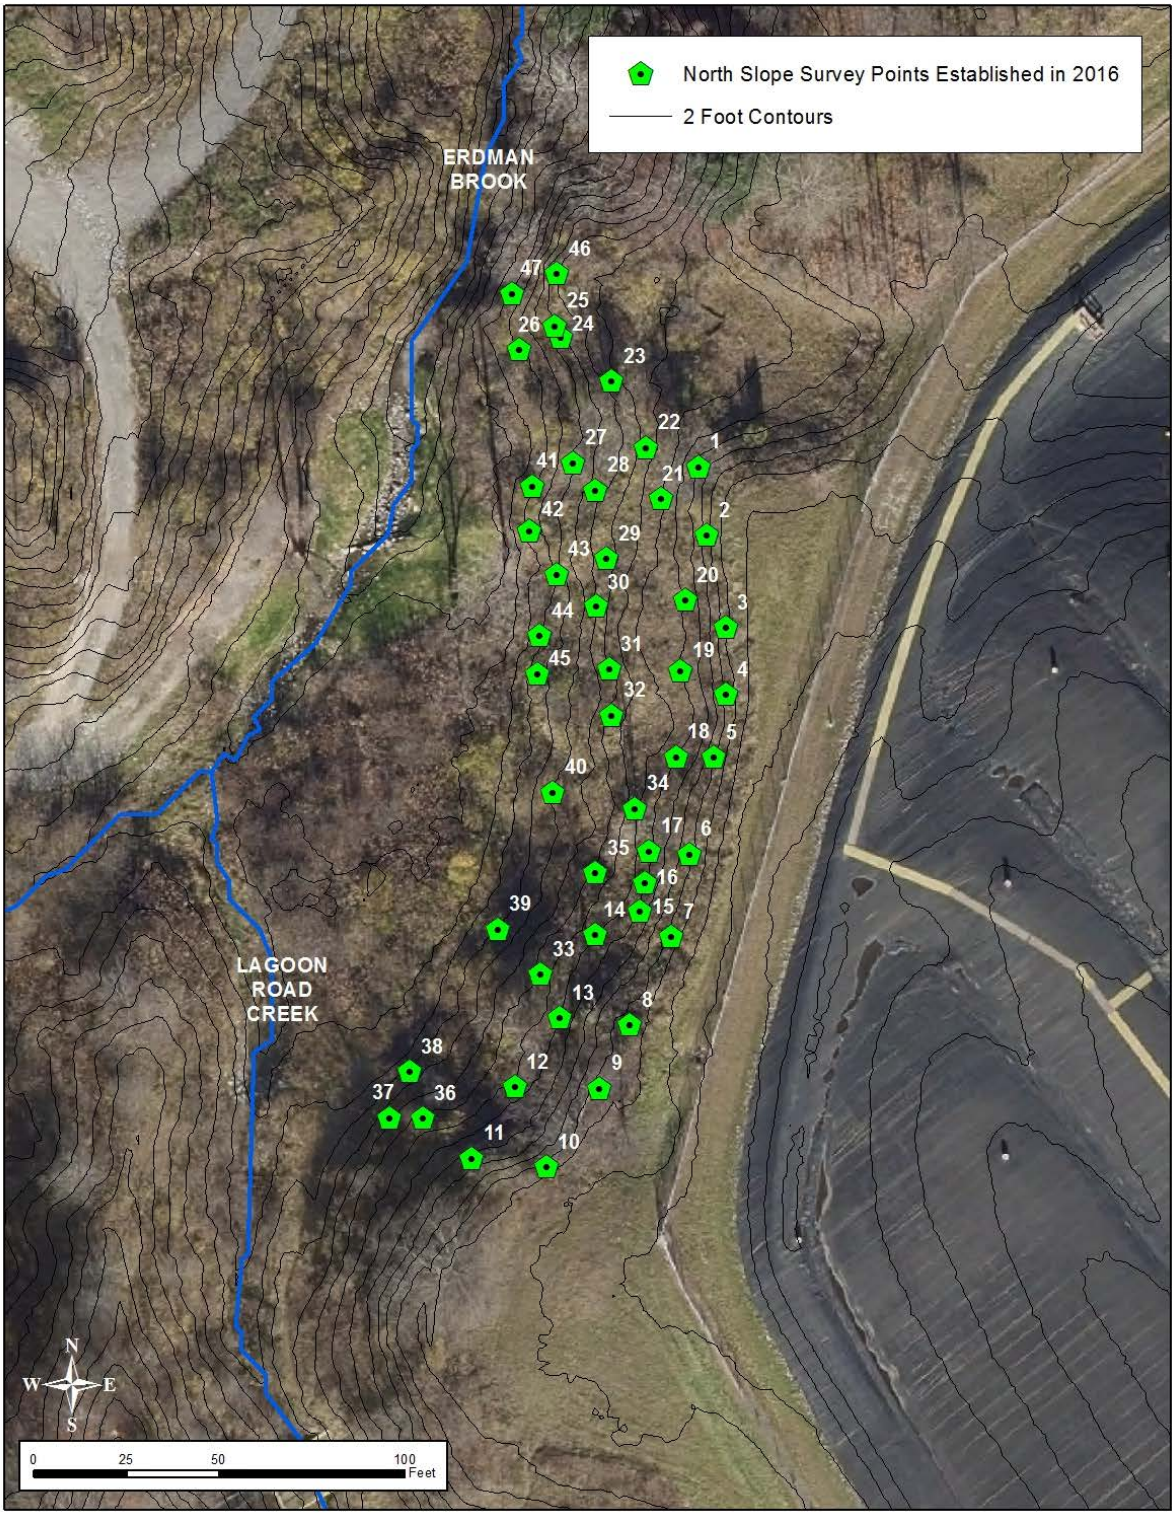
Figure 4-4. North Slope Ground Surface Elevation Survey Points

The 2021 elevations of the North Slope monitoring points (see Figure 4-4) are provided in Table F-1. A comparison between the 2020 and 2021 data showed four points (NS EXIR – 5, 6, 15, and 17) having a reportable change (>0.5 ft) in elevation. DEC had been made aware of the movement and participated in periodic observations. NYSERDA has and continues to provide DEC with North Slope survey data and documentation of each of the North Slope observations.

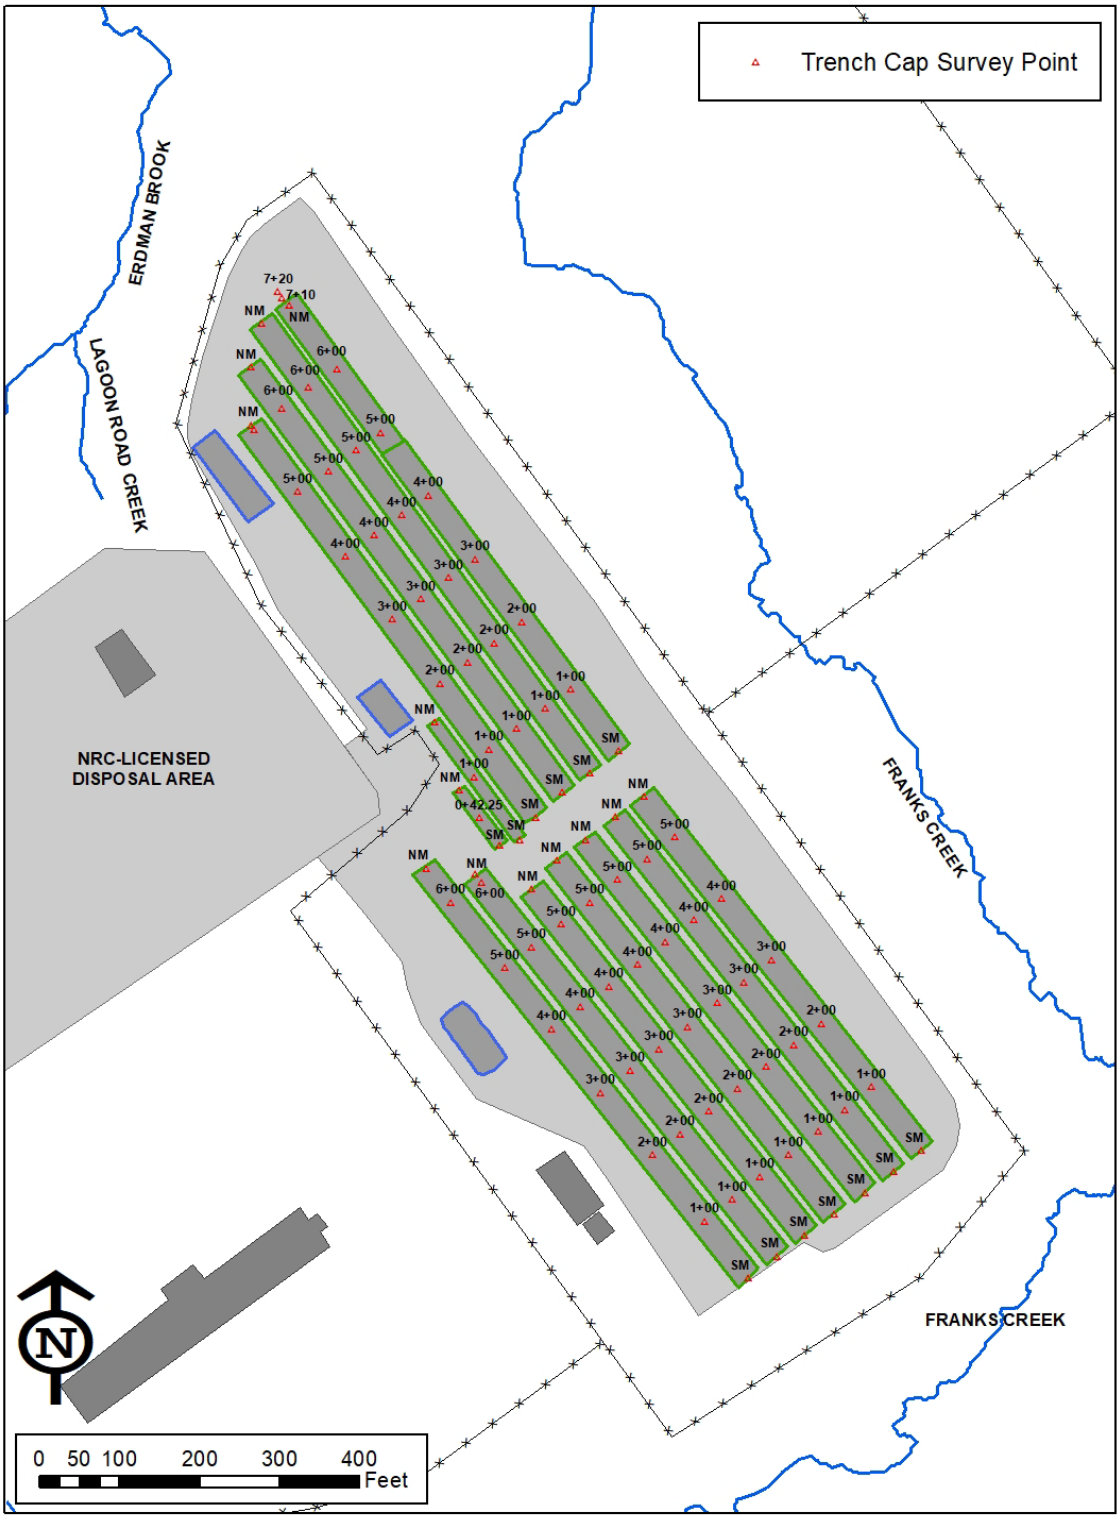
Figure 4-5. Trench Cap Ground Surface Elevations Survey Points

Areas of settlement were observed in 2013 on the southernmost 100-foot sections of Trench 13 as well as the northern area of Trench 14. Since 2014, NYSERDA has conducted a focused topographic survey in each of the areas identified above using a 10-foot grid pattern to monitor the rate of subsidence. A very slight decreasing trend of downward movement since 2013 has been identified. The downward movement is just above the uncertainty of the survey measurements.

In 2017, Trench 8 settlement was mitigated during the installation of the new geomembrane cover by installing lightweight geofoam blocks to raise the areas of settlement before covering with the new geomembrane cover. A settlement gauge was also installed to further monitor the trench cap surface of Trench 8 after the installation of the geofoam panels. The settlement gauge elevation measurements have decreased by 0.05 ft since installation in October 2017, which is within the survey measurement uncertainty. NYSERDA will continue to monitor this area of Trench 8.

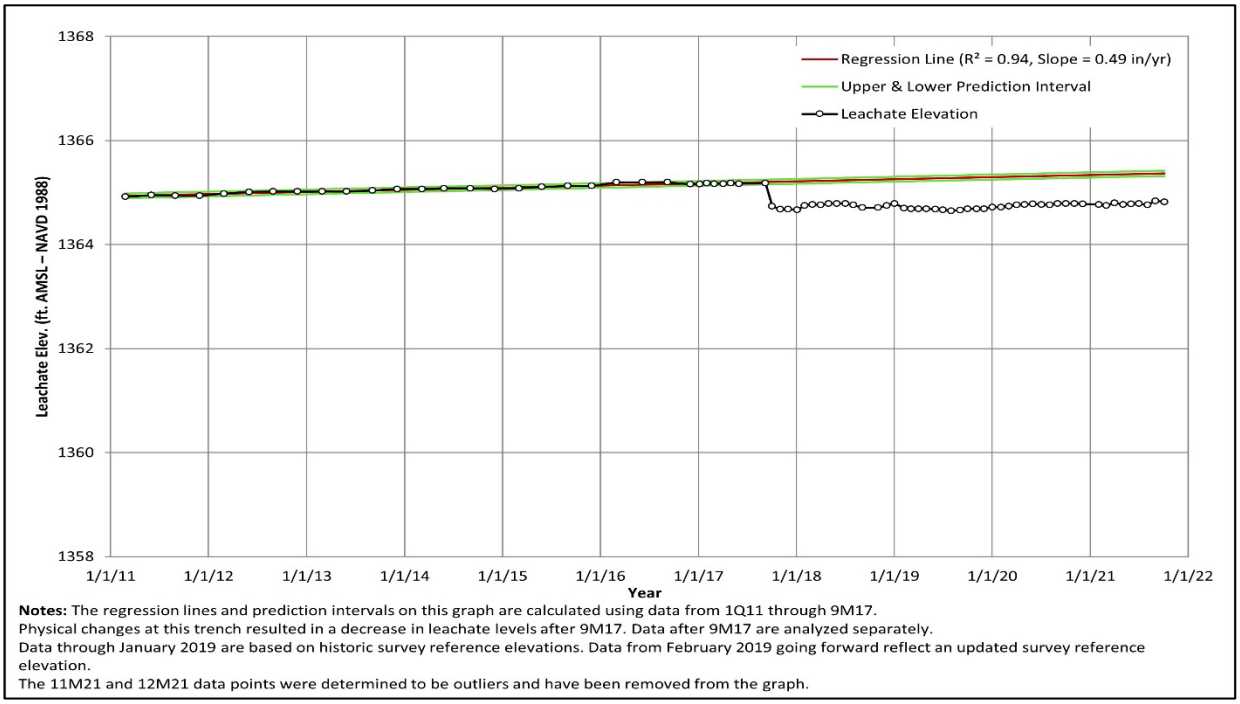
Figure A-1. 2011-2017 Leachate Elevations, Trench 1

statistical outliers or anomalies, and if included in the long-term trending for Trench 1, skew the results (i.e., the long-term trend for Trench 1 is slighting increasing; but if these data points are included, the long-term trend is slightly decreasing). For the purpose of long-term trending, the three data points are removed from the Trench 1 graphs (Figures A-1 and A-2) but will not be removed from the data population until NYSERDA evaluates if there are any physical changes in the trench sump that may be creating this measurement variability. NYSERDA will continue to monitor and evaluate the leachate elevation in Trench 1.

Notes: The regression lines and prediction intervals on this graph are calculated using data from 1Q11 through 9M17.
Physical changes at this trench resulted in a decrease in leachate levels after 9M17. Data after 9M17 are analyzed separately.
Data through January 2019 are based on historic survey reference elevations. Data from February 2019 going forward reflect an updated survey reference elevation.
The 11M21 and 12M21 data points were determined to be outliers and have been removed from the graph.

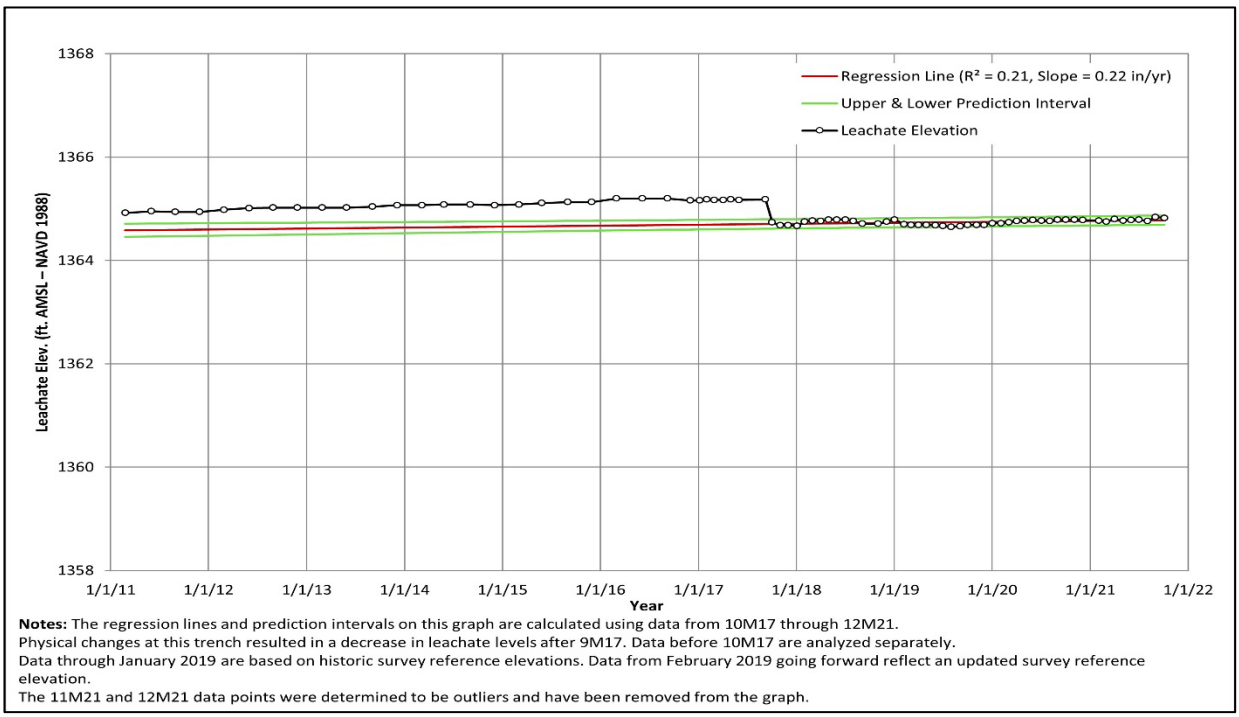
Figure A-2. 2017-2021 Leachate Elevations, Trench 1

The leachate levels in the Trench 1 sump are continuing to show a slight increasing trend, but significant variability in the data collected in November and December 2021, and in early 2022 was observed, which was above NYSERDA's reporting trigger, and was communicated to the New York State Department of Environmental Conservation (DEC) in February 2022. The Trench 1 leachate elevations returned to historical levels in February 2022. NYSERDA will be conducting additional monitoring, inspection, and evaluation of the trench sump conditions and measurement device functionality testing in Trench 1 during 2022 to determine if there are physical conditions in the sump that are contributing to the variability in measurements.

Notes: The regression lines and prediction intervals on this graph are calculated using data from 10M17 through 12M21.
Physical changes at this trench resulted in a decrease in leachate levels after 9M17. Data before 10M17 are analyzed separately.
Data through January 2019 are based on historic survey reference elevations. Data from February 2019 going forward reflect an updated survey reference elevation.
The 11M21 and 12M21 data points were determined to be outliers and have been removed from the graph.

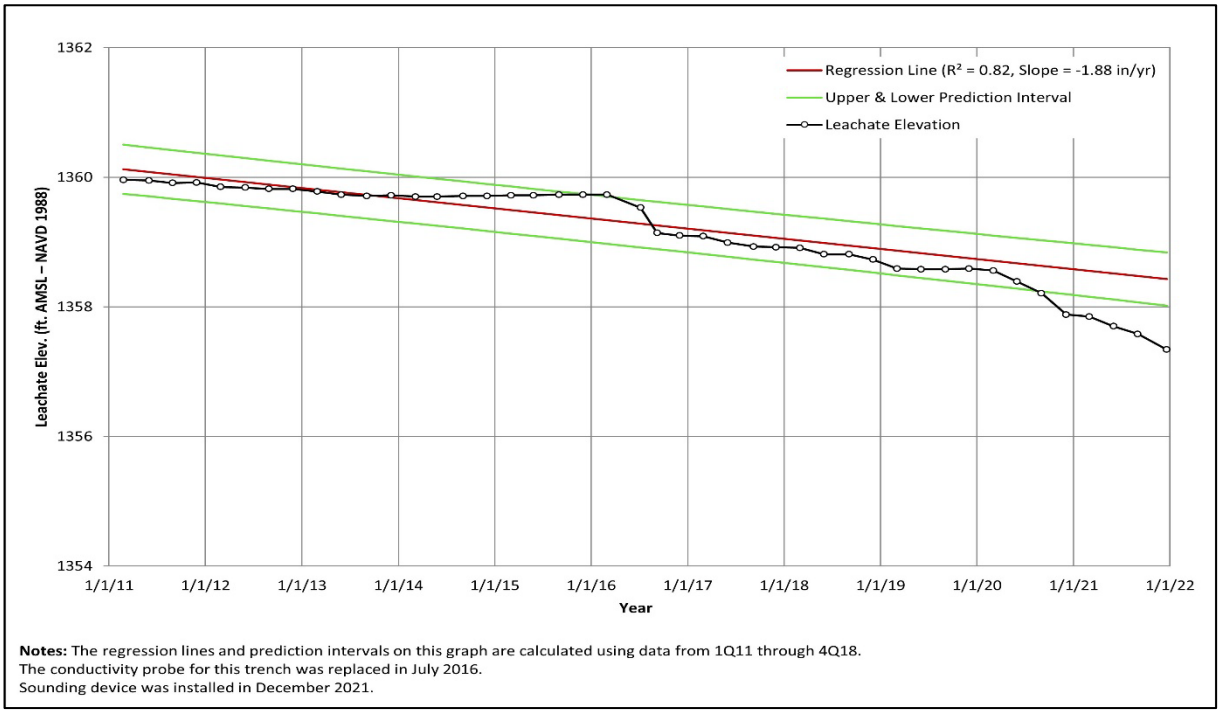
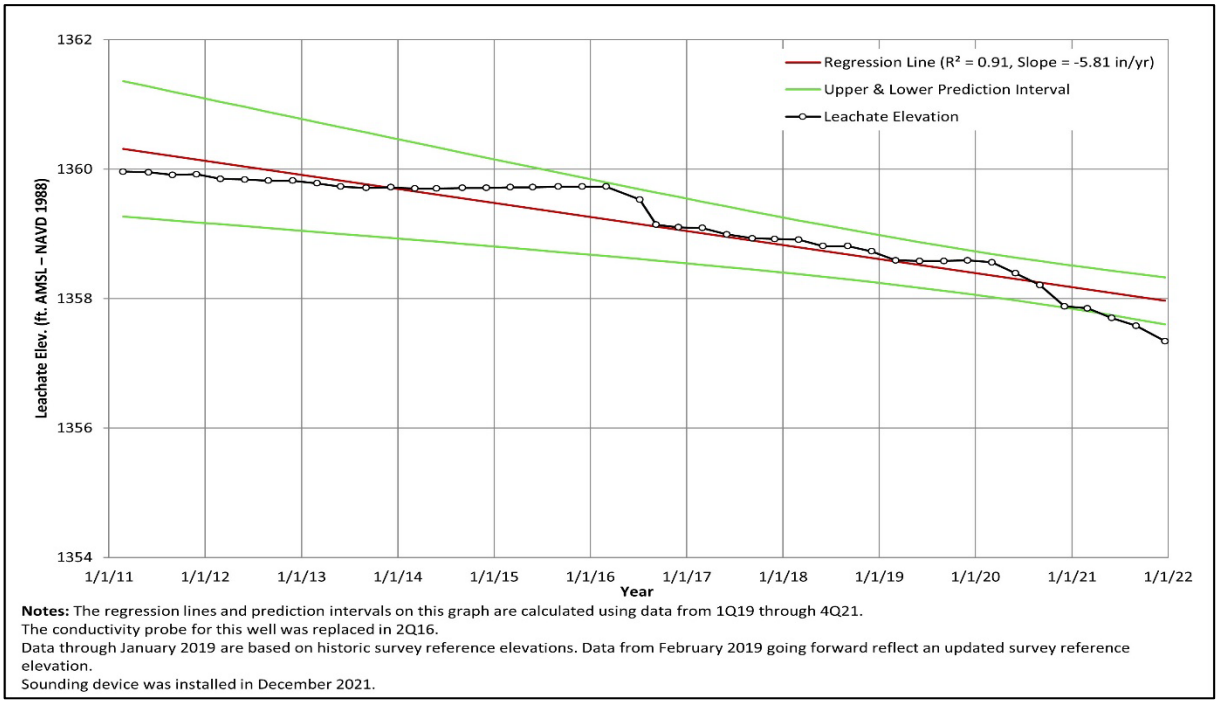
Figure A-4. 2011-2018 Leachate Elevations, Trench 3

Trench 3 had been exhibiting a decrease of 1.88 inches per year through the end of 2019. Beginning in 2020, the rate of deceleration increased, resulting in a negative 2.10 inches per year by the end of 2020, and a negative 5.8 inches in 2021. This change is under evaluation, but there is no indication of any change in the containment effectiveness of the trench. We also note that the measurement device installed in Trench 3 began to fail in the fall of 2021 and was replaced in December 2021 with a sounding device.

Notes: The regression lines and prediction intervals on this graph are calculated using data from 1Q11 through 4Q18.
The conductivity probe for this trench was replaced in July 2016.
Sounding device was installed in December 2021.

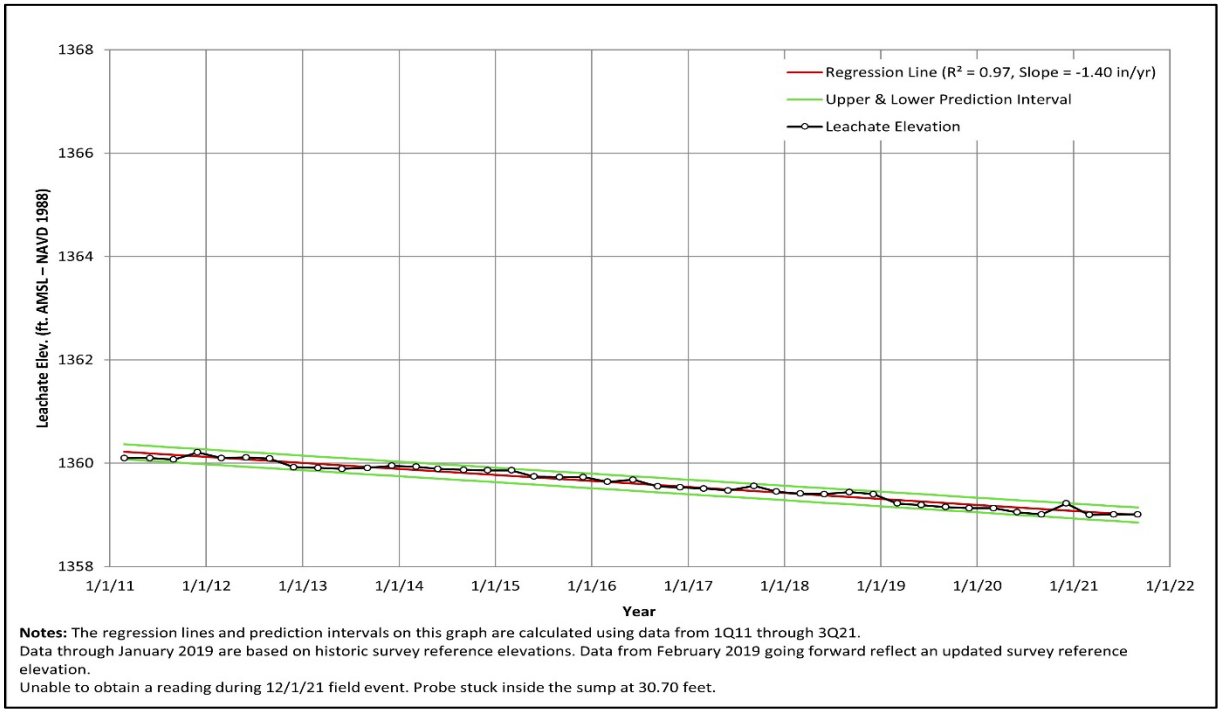
Figure A-9. 2011-2021 Leachate Elevations, Trench 9

Notes: The regression lines and prediction intervals on this graph are calculated using data from 1Q11 through 3Q21.
Data through January 2019 are based on historic survey reference elevations. Data from February 2019 going forward reflect an updated survey reference elevation.
Unable to obtain a reading during 12/1/21 field event. Probe stuck inside the sump at 30.70 feet.

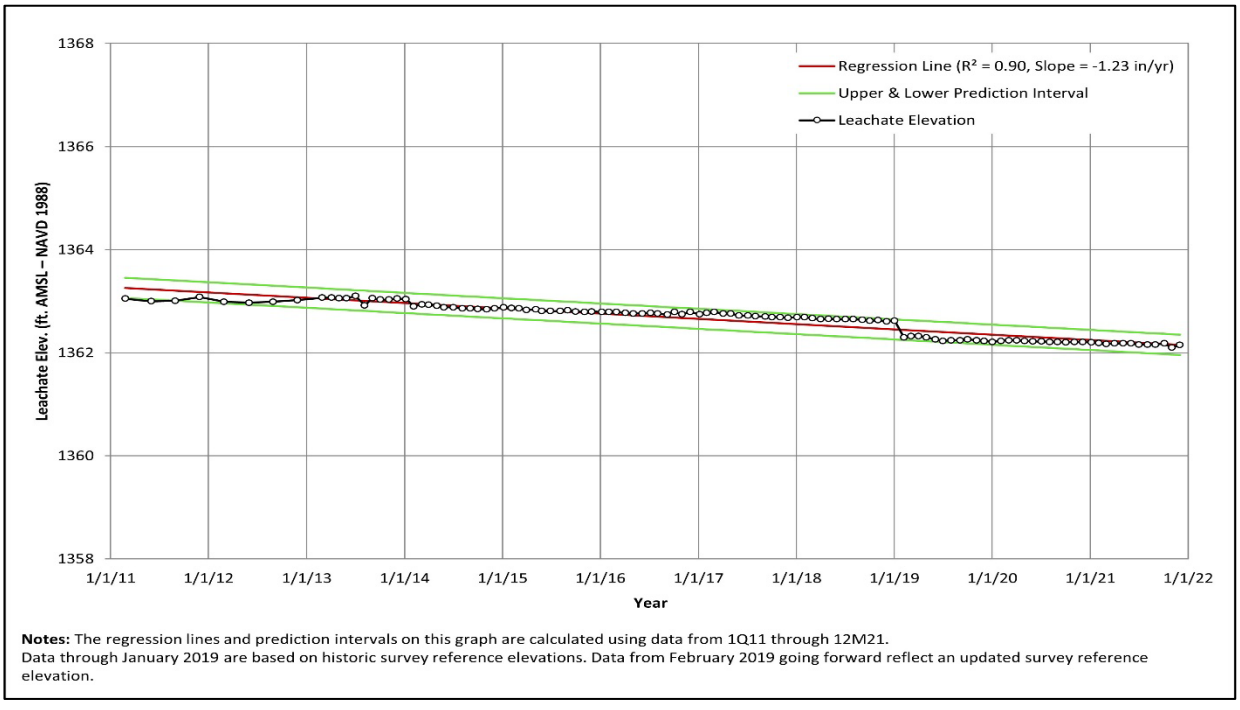
Figure A-15. 2011-2021 Leachate Elevations, Trench 14

As described below, an increase in the Trench 14 leachate elevation has been observed since 2011 following a period of consistent decrease (see Figure A-15). Based on the regression analysis plotted in Figure A-15, between 2011 and 2021, Trench 14 has been increasing at approximately 0.66 inches per year. During the fourth quarter of 2020, changes in the performance of the water level probe were noted, and an evaluation of the probe was performed in 2021; it was determined that the conductivity probe in Trench 14 sump was failing. The conductivity probe was replaced in March 2021, and subsequent readings collected from that point forward indicate a stable or slightly downward trend in the Trench 14 leachate elevation.

Following the installation of infiltration controls in the mid-1990s, the Trench 14 leachate elevation followed a consistent and generally predictable decreasing trend. A noteworthy change in behavior of this trend occurred in approximately 2008 through 2011 when the decreasing trend leveled off, as shown in Figure A-15. Small increases and decreases have been observed since 2011; but overall, the Trench 14
